## Influence of Lightning Discharge on Microstructure, Mechanical Properties and Failure of Armature Steel

Influence of lightning discharge on microstructure, mechanical properties and failure of armature steel was investigated. The studied specimens were picked out from the reinforcement construction destroyed during storm. Metallographic analysis by optical microscope LMA combined with video camera YCH15 was carried out. Pictures of the affected structure were picked out by electron scanning microscope SEM EVO 50 as well using secondary electron detector SE. Chemical composition was determined with the dispersive energy spectrometer INCAx-sight EDS. Micro hardness of the specimens was measured by HMT 3 device with load 0.49 N (in some cases 0.196 N and 0.098 N). Grey, black or white zones in the cross-section of steel samples were determined. It was found that these zones might be hard or brittle, may vary in shape, size and phase composition. It may have or not metallic properties. The article presents analysis of the chemical composition changes at the affected zones, but it also requires for further investigations of lightning discharge effect on armature steel.

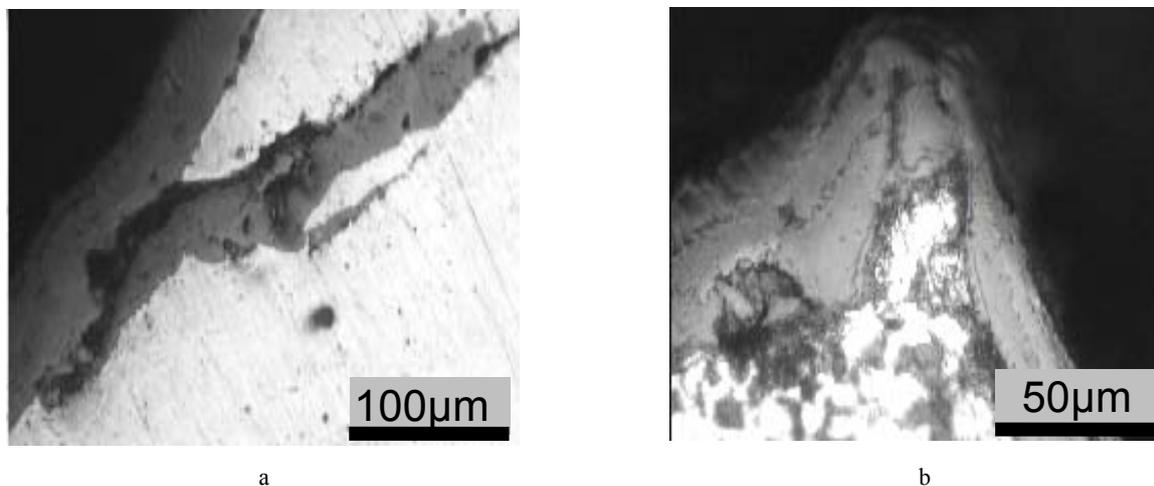
1. Hardened zones looking grey at the polished surface (Fig. 1, a) and resistant to etching by 3 % HNO<sub>3</sub> solution in ethanol (Fig. 1, b);
2. Wedge-shaped interposed formations going from surface and tapering to the depth lengthwise the rod (Fig. 1, a; Fig. 2, b) or locating near the borders of armature across the rod (Fig. 2, a). The formations have various depth, shape and phase composition, they are grey or grey and black;
3. Micro hardness HV<sub>0.49</sub> of grey formations varies in wide ranges: 4325...10071 MPa in bright grey homogeneous zones, and 916...2834 MPa in dark grey inhomogeneous areas (micro hardness HV<sub>0.49</sub> of matrix

**Fig. 1.** Surface of armature steel rod No 1 affected by lightning: a – polished; b – etched by 3 % HNO<sub>3</sub> solution in ethanol

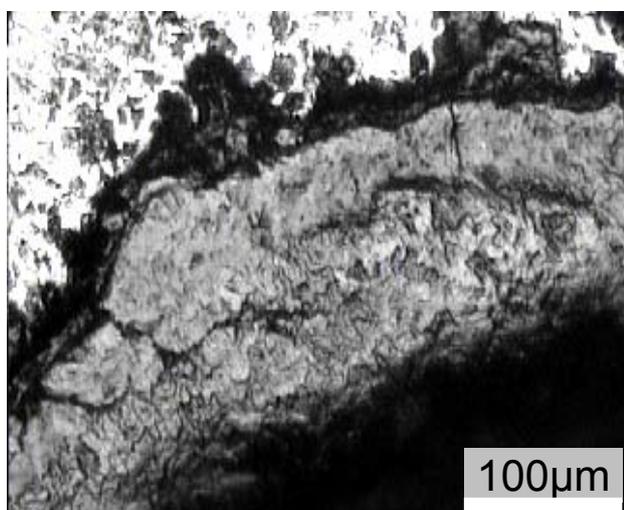
**Fig. 3.** Microstructure of surface of armature rod No 1 affected by lightning discharge picked up by optical microscope LMA. Etched by 3 %  $\text{HNO}_3$  solution in ethanol. Structure: ferrite, pearlite, grey and black formations

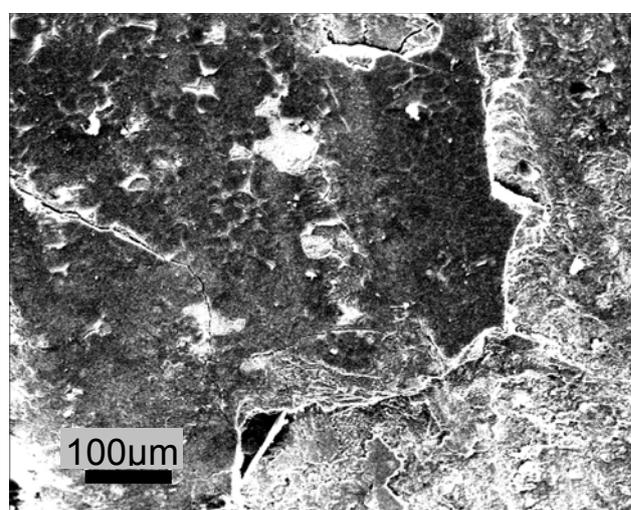
**Fig. 4.** Microstructure of surface of armature rod No 1 affected by lightning discharge picked up by electron scanning microscope SEM EVO 50. Cracks and metal formations are black, non-metal formations – white

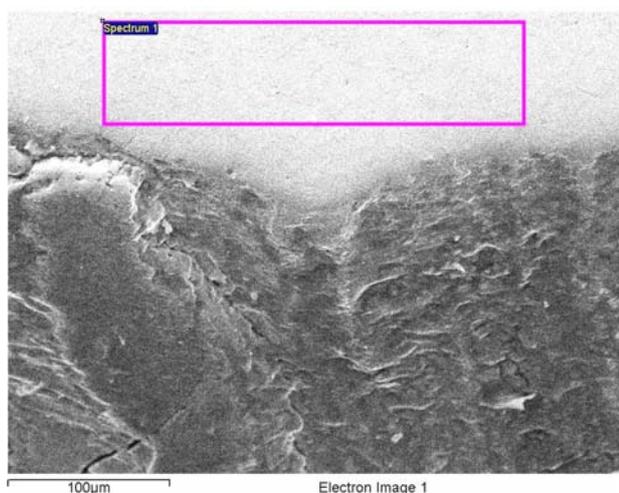
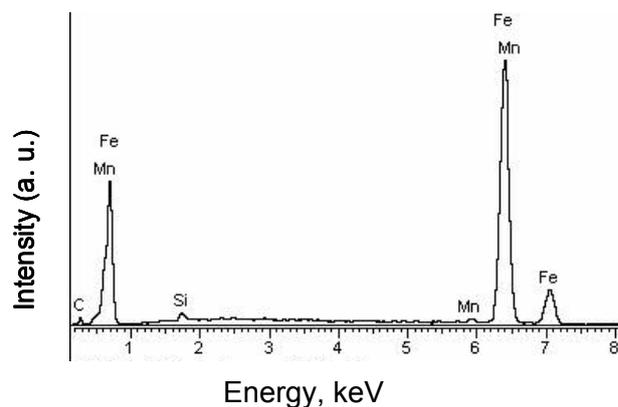
Analyzing element composition by INCAx-sight EDS in 200 μm<sup>2</sup> zone of unchanged microstructure, which locates about 50 μm from the zone affected by lightning discharge (Fig. 5, Table 1) carbon amount was found 4.3 %. Determining element composition of the 500 μm<sup>2</sup> affected zone (Fig. 6, Table 2) that locates approximately 90 μm from the dividing line, amount of carbon has increased up to 17.49 %. Content of silicon and manganese changed fractionally near the affected zone.

**Fig. 5.** Influence of lightning discharge on chemical composition of at the surface armature steel rod No 1: a – zone of spectrum analysis; b – spectrum analysis of elemental composition of the main metal. SEM EVO 50 (chemical composition is presented in Table 1)

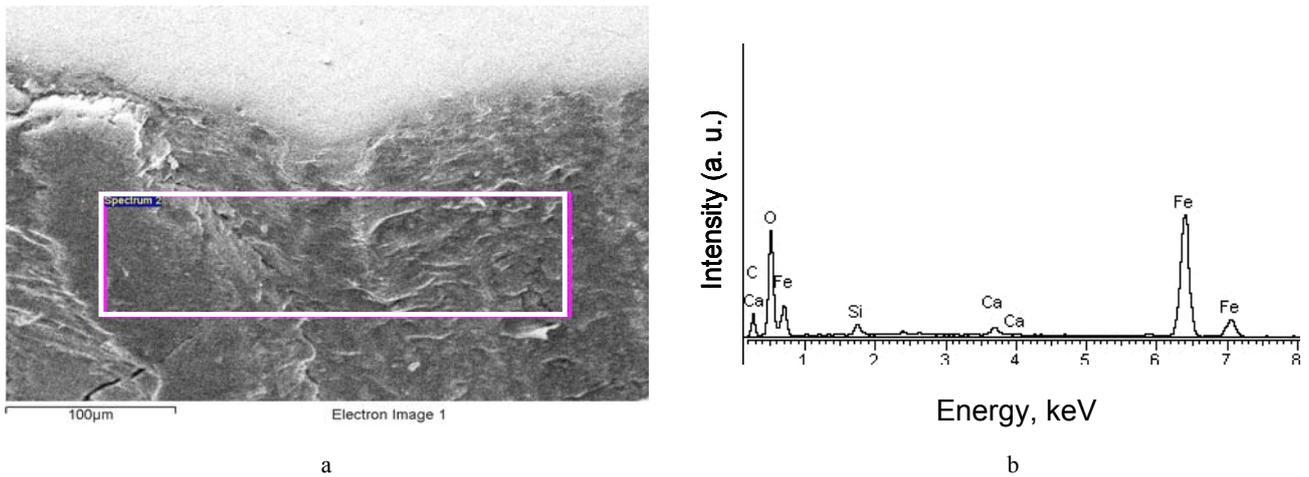
This formation contains also oxygen (26.32 weight percent), calcium (1.06 weight percent), an amount of silicon has increased from 0.73 % until 1.07 %, but manganese has disappeared (Table 2).

**Fig. 6.** Influence of lightning discharge on chemical composition of at the dividing line between main metal and affected zone (rod No 1): a – zone of spectrum analysis; b – spectrum analysis of elemental composition of the main metal. SEM EVO 50 (chemical composition is presented in Table 2)

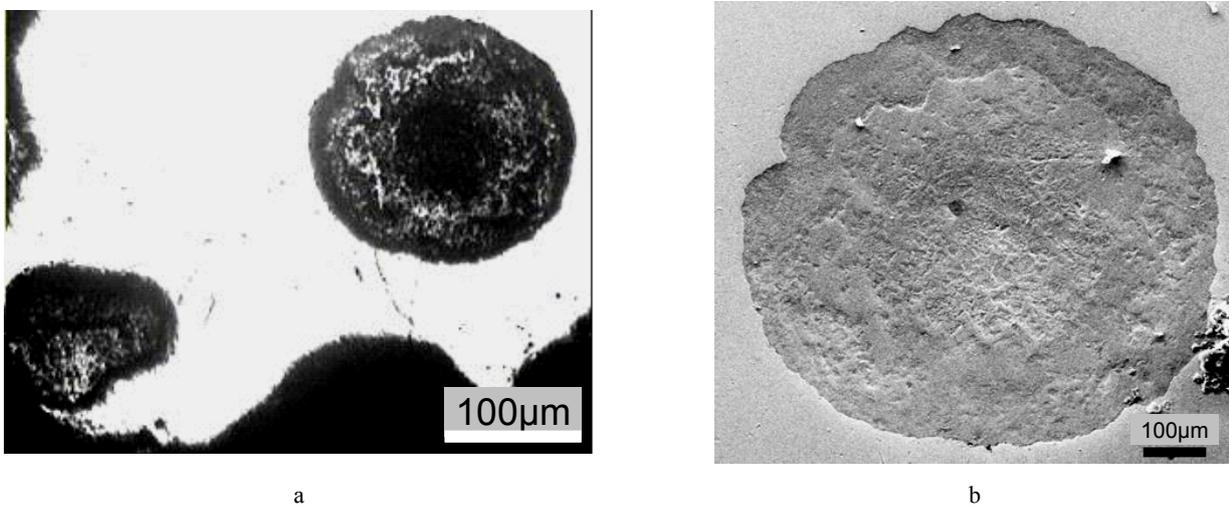
Cylindrical formation as 700 μm diameter circle and located about 300 μm from the surface was dedicated (Fig. 7). Distribution of its chemical composition was determined and is listed in Table 3. There was no carbon found near this formation. Itself it has contained decreasing amount of carbon – from 5.57 % till 6.90 %. This formation has not contained magnesium, although the investigated steel has 1.10 % Mn.

**Fig. 7.** Surface structure of specimen rod No 2 affected by lightning discharge observing by optical microscope (a) and by SEM EVO-50 (b)
