Analysis of Failure Causes of 0Cr19Ni9 Blade Crack

In this paper, fracture morphology observation, microstructure analysis, standard corrosion test, and other experimental methods are used to analyze the causes of corrosion and cracking of steam turbine blades (0Cr19Ni9) produced by a certain company. The results showed that cracks appeared during the operation of the blade. A large number of dimples were observed under the scanning electron microscope, almost all of which were shear dimples; at the same time, fatigue bands were also distributed in them. The internal cause of the cracks is the long-term service, which causes the carbon and the alloy to undergo a diffusion reaction to form carbon-rich areas and carbides. They are thermally corroded in the service environment, and the carbon-rich zone is reduced, which reduces the strength of the zone; carbides accumulate at the grain boundary, causing groove-shaped defects at the grain boundary to form a cutting effect. It is easy to form a source of fatigue cracks. The external cause is that the material is subjected to transverse stress for a long time during operation, which leads to the generation of cracks. This article analyz

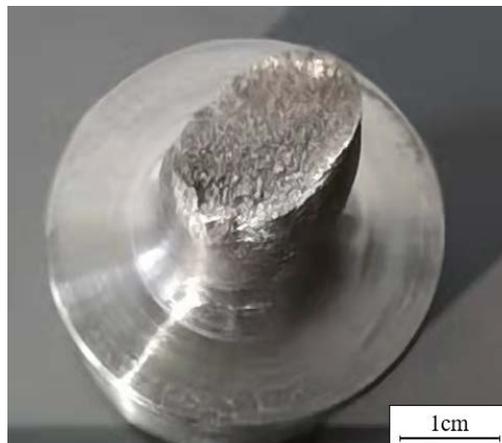
The appearance and morphology of the tensile fracture of the sample are shown in Fig. 2. The macroscopic appearance of the fracture is flat. There is obvious plastic deformation near the fracture of the specimen. The shape of the fracture is necked, the maximum shear stress in the fracture direction is parallel, and the angle of 45° with the principal stress direction can be judged to be plastic fracture [9].

Fig. 2. Fracture morphology of tensile specimen of 0Cr19Ni9 test steel

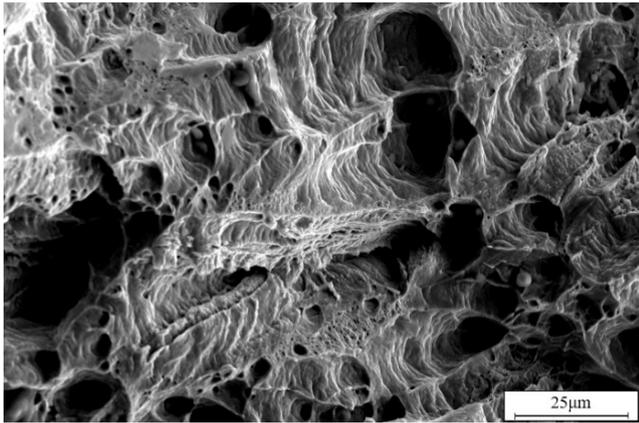
Fig. 3 shows the microscopic morphology of the tensile sample observed under the SEM. It can be seen from Fig. 3 that there are a large number of dimples in the sample, almost all of which are shear dimples. Except for the existence of dimples, fatigue bands are also distributed in them. After the macroscopic and microstructure observation of the tensile specimen, it is judged that the fracture is a plastic fracture [10]. Studies have shown that 0Cr19Ni9 steel is an austenitic stainless steel, which has excellent plastic toughness and also exhibits good plastic toughness during the stretching process [11]. Fig. 4 shows the tensile stress-

Fig. 3. Microscopic morphology of the tensile specimen

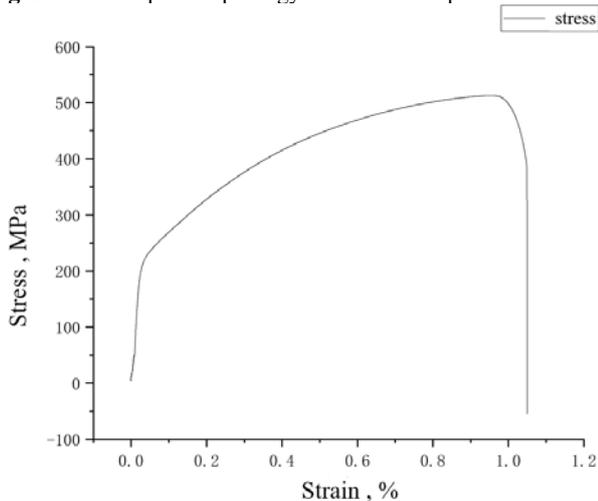
strain curve. According to Fig. 4, the plasticity and toughness of the samples are all excellent. The actual observed phenomenon also confirms this argument.

Fig. 4. Tensile stress-strain curve of 0Cr19Ni9

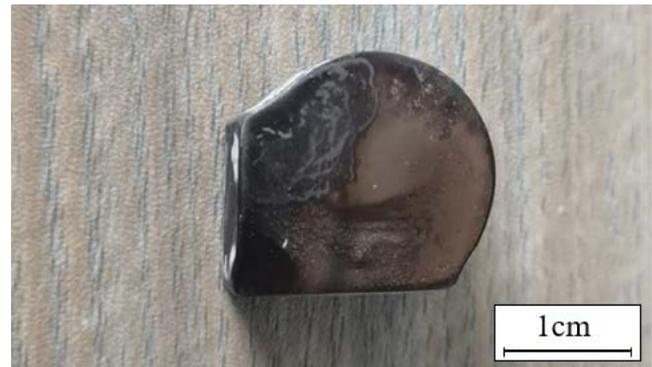
Fig. 5 shows the corroded surface of a standard test specimen of GB/T 4334-2008 intergranular corrosion. The surface of the sample is gray-black as a whole, with knife-like corrosion. It is judged that there is a tendency of intergranular corrosion, but further observation by metallographic method is still needed.

Fig. 5. Standard macro morphology of intergranular corrosion

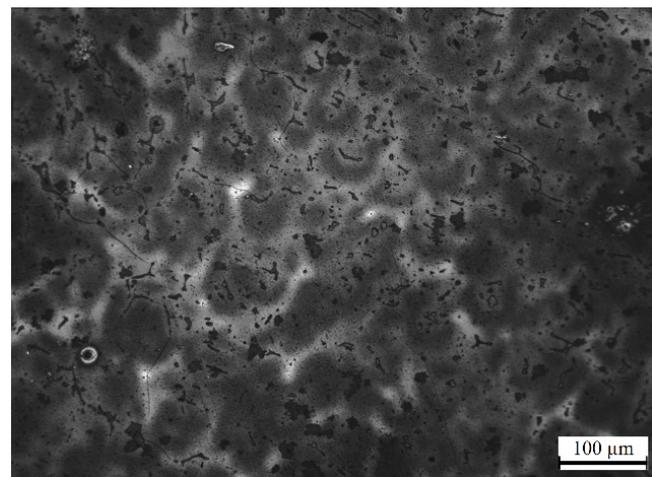
The metallographic microstructure of 0Cr19Ni9 steel is corroded for 144 h in a slightly boiling state in the nitric acid solution, as shown in Fig. 6. It can be seen that there is a gray-black morphology, in which the gray-black matrix is austenite, and the black strips are the corrosion pits left after carbide corrosion. They are distributed in discontinuous bands between the austenite crystals, and the metallographic

structure is microscopic. The structure is characterized by obvious intergranular corrosion structure.

Fig. 6. Corrosion 144 h metallographic microstructure in the slightly boiling state of nitric acid

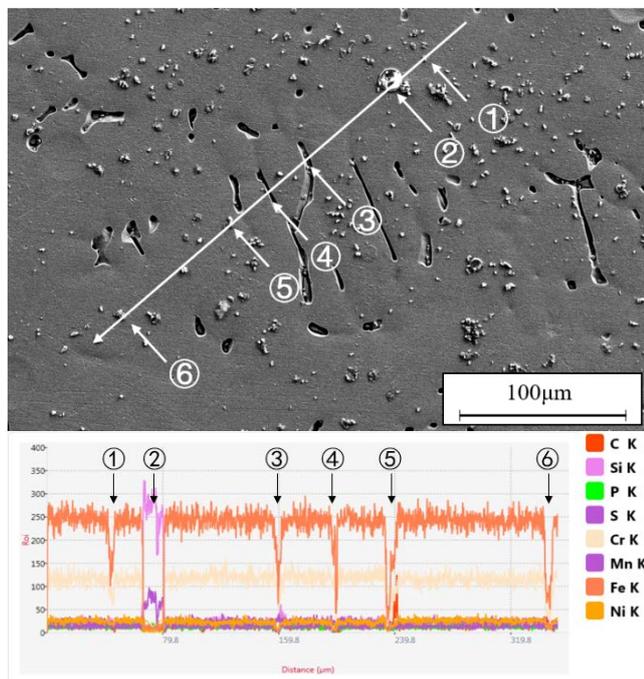
SEM was used to observe the surface of the first corroded sample as shown in Fig. 7. ①~⑥ representing the points where the EDS line spectrum fluctuates.

It can be seen from Fig. 7 that at ①④⑥, the radiation peaks intensity of Fe, Cr, and C drop sharply, and there is no increase in the radiation peaks of other elements, indicating that this is due to the pits formed after corrosion. At ②, the radiation peaks intensity of Si and Mn increase sharply, and are in a certain ratio, indicating that this is a Si-Mn metal compound. At ③, the radiation peaks intensity of Fe, Cr, Ni and C drop sharply, and the radiation peaks intensity of Si and Mn increase slightly, indicating that the pits formed after etching here expose the Si-Mn metal compound under the pits. At ⑤, the radiation peaks intensity of Fe and Cr drop

sharply, and at the same time, the radiation peak intensity of C increases. The author suspects that it is a pit formed after the chromium-rich area was corroded by the etching solution.

Fig. 7. 0Cr19Ni9 microstructure morphology

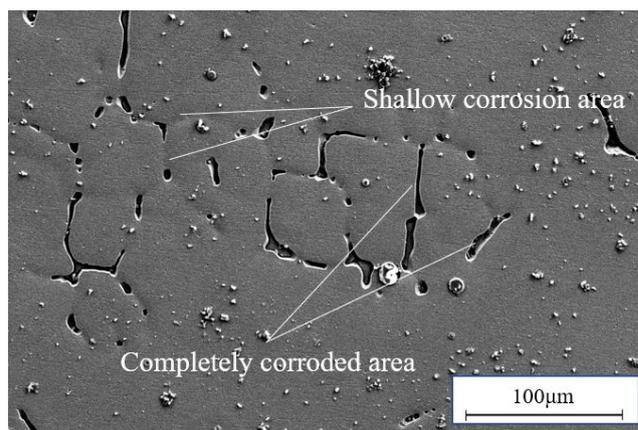
Based on the original corrosion experiment, the corrosion time is shortened. The observation under SEM is shown in Fig. 8. After reasonable corrosion, it can be observed that there is a concave area on the surface of the sample, which is a shallow corrosion area. Compared with the completely corroded area, in the shallow corroded area, only part of the material that caused the intergranular corrosion was corroded by the etching solution, and part of the material remained on the surface of the sample. The material composition can be detected by EDS. Fig. 9 shows the EDS scan result of the longitudinal edge of the sample. The scan result shows that there are carbides in ① and ②. At ①, the carbon content rises sharply, and the content of Fe and Cr drops sharply. There is precipitation of $Cr_{23}C_6$ [14, 15]. Cr should be enriched here, resulting in the surrounding Cr content being lower than that of the matrix. The Cr is more sensitive to the etching solution, but the C is less sensitive to the etching solution. Therefore, when $Cr_{23}C_6$ is corroded away, the Cr is separated from the substrate with the etching solution, and C remains on the surface of the substrate, causing the Cr content to continue to decrease here, while the C content exceeds the normal value. At ②, the content of C rises sharply, the content of Fe continues to decrease, and the content of Cr decreases slightly, which also proves the above. Due to the short corrosion time of the etching solution, some carbides are corroded, but there are still some carbides left on the surface of the substrate. The sharp increase in C content is due to the precipitation of C here. C combines with the surrounding Cr atoms to form $Cr_{23}C_6$ type carbides.

The etching solution corrodes some of the carbides, resulting in a decrease in the Cr content. At the same time, Cr content around ② is also lower than the surrounding value, which can also indicate that Cr atoms are enriched

here, forming a chromium-rich zone, and the surrounding is a chromium-poor zone [16]. It further proves that the test steel has a tendency of intergranular corrosion.

Fig. 8. 0Cr19Ni9 surface appearance of shallow corrosion

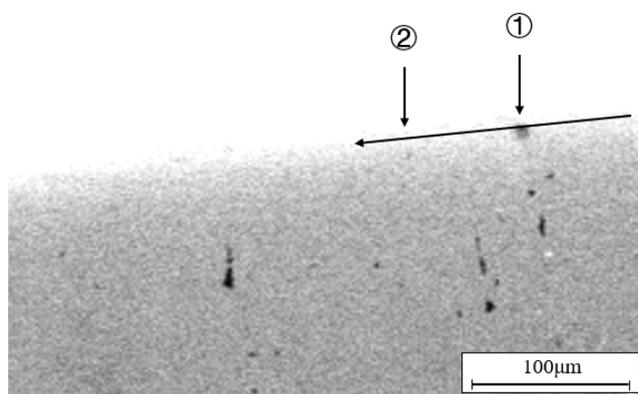
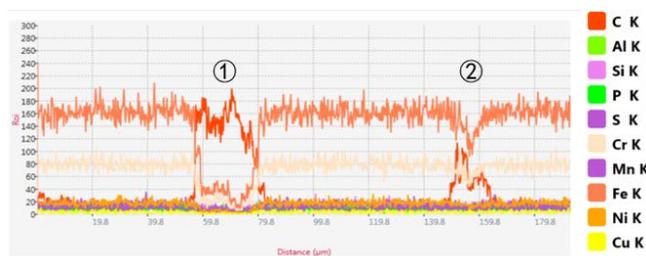
Fig. 9. 0Cr19Ni9 EDS scanning of longitudinal polishing edge

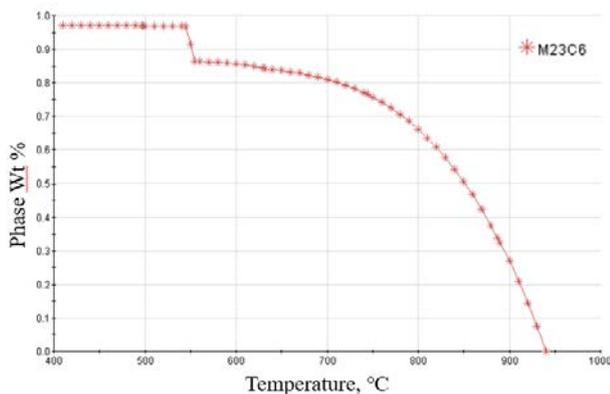
The carbon content of 0Cr19Ni9 steel is 0.054 wt.%, and the C content is relatively high, which induces obvious segregation of components [18]. The area with large C cannot be completely dissolved in austenite. When working within the sensitization temperature of intergranular corrosion, a large amount of C atoms are precipitated from the supersaturated γ -Fe solid solution. Because C can be closely combined with the surrounding alloy elements. When it meets the surrounding Cr, they will form many different types of carbides. According to the results calculated by JMatPro, we can see that the main carbide is Cr_{23}C_6 , and no other types of carbides are produced, as shown in Fig. 11.

Fig. 11. Computational simulation of carbide precipitation by JMatPro

In production activities, the working environment of the blade cannot be changed, so it can only be improved from internal factors. This article points out that the occurrence of intergranular corrosion leads to the germination of crack sources. The content of C has a great influence on the susceptibility of the material to intergranular corrosion. With a small increase in the C content, the susceptibility of the material to intergranular corrosion will be greatly increased. Therefore, in the process of preparing the material, the C content should be appropriately reduced within the range allowed by the grade, which can effectively reduce the generation of intergranular corrosion. In addition, strong carbide formation elements like Ti and Nb are added to form stable TiC or NbC. It can stabilize the structure and prevent the formation of Cr_{23}C_6 and the generation of chromium-depleted areas, thereby improving the tendency to remove intergranular corrosion [19]. In order to achieve the purpose of eliminating intergranular corrosion, the amounts of Ti and Nb added to the steel are respectively: $0.8\% \geq \text{Ti} \geq 5\%$, $1\% \geq \text{Nb} \geq 10\%$ [20].
