Influence of Lightning Discharge on Microstructure, Mechanical Properties and Failure of Armature Steel

Influence of lightning discharge on microstructure, mechanical properties and failure of armature steel was investigated. The studied specimens were picked out from the reinforcement construction destroyed during storm. Metallographic analysis by optical microscope LMA combined with video camera YCH15 was carried out. Pictures of the affected structure were picked out by electron scanning microscope SEM EVO 50 as well using secondary electron detector SE. Chemical composition was determined with the dispersive energy spectrometer INCAx-sight EDS. Micro hardness of the specimens was measured by IIMT 3 device with load 0.49 N (in some cases 0.196 N and 0.098 N). Grey, black or white zones in the cross-section of steel samples were determined. It was found that these zones might be hard or brittle, may vary in shape, size and phase composition. It may have or not metallic properties. The article presents analysis of the chemical composition changes at the affected zones, but it also requires for further investigations of lightning discharge effect on armature steel.

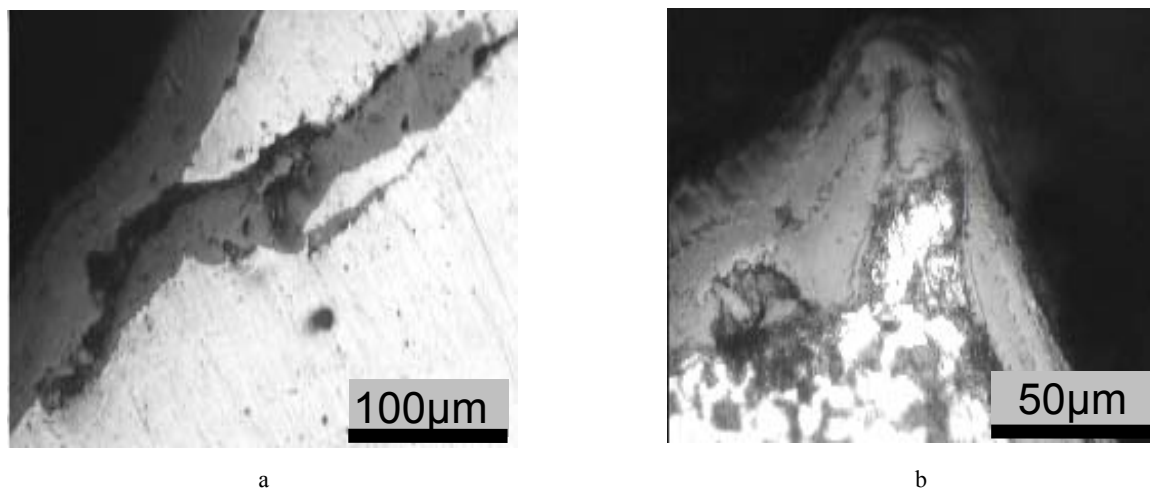
1. Hardened zones looking grey at the polished surface (Fig. 1, a) and resistant to etching by 3 % HNO₃ solution in ethanol (Fig. 1, b);
2. Wedge-shaped interposed formations going from surface and tapering to the depth lengthwise the rod (Fig. 1, a; Fig. 2, b) or locating near the borders of armature across the rod (Fig. 2, a). The formations have various depth, shape and phase composition, they are grey or grey and black;
3. Micro hardness HV_{0.49} of grey formations varies in wide ranges: 4325...10071 MPa in bright grey homogeneous zones, and 916...2834 MPa in dark grey inhomogeneous areas (micro hardness HV_{0.49} of matrix

Fig. 1. Surface of armature steel rod No 1 affected by lightning: a – polished; b – etched by 3 % HNO₃ solution in ethanol

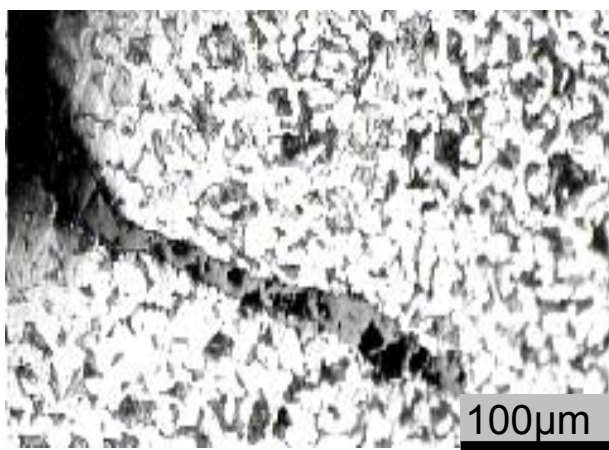
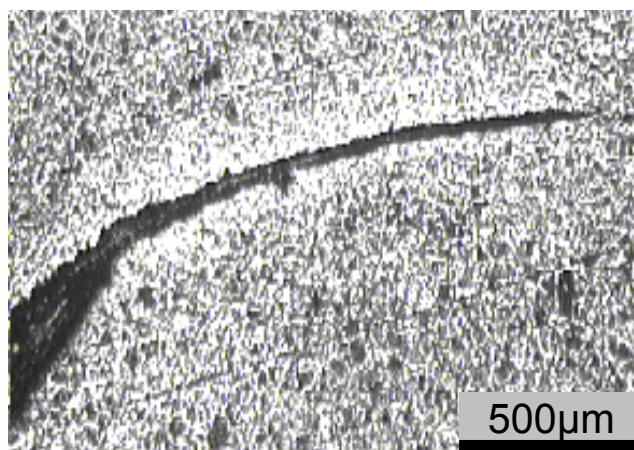
Fig. 2. Cracks caused by lightning discharge in armature rods No 1: a – across the rod (magnification $\times 16$); b – along the rod. Etching by 3 % HNO_3 solution in ethanol

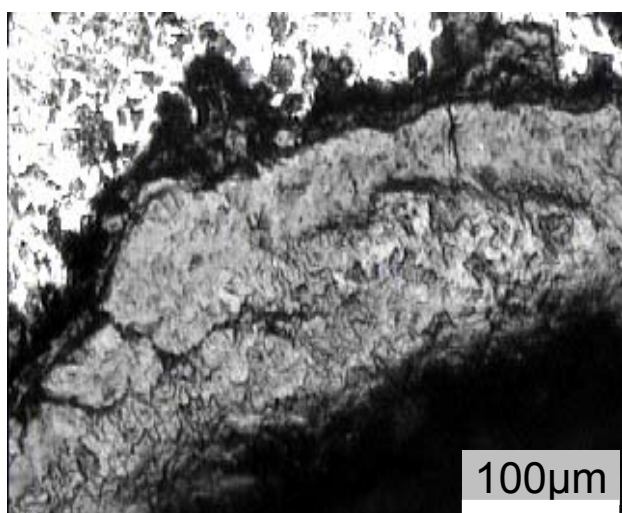
Fig. 3. Microstructure of surface of armature rod No 1 affected by lightning discharge picked up by optical microscope LMA. Etched by 3 % HNO_3 solution in ethanol. Structure: ferrite, pearlite, grey and black formations

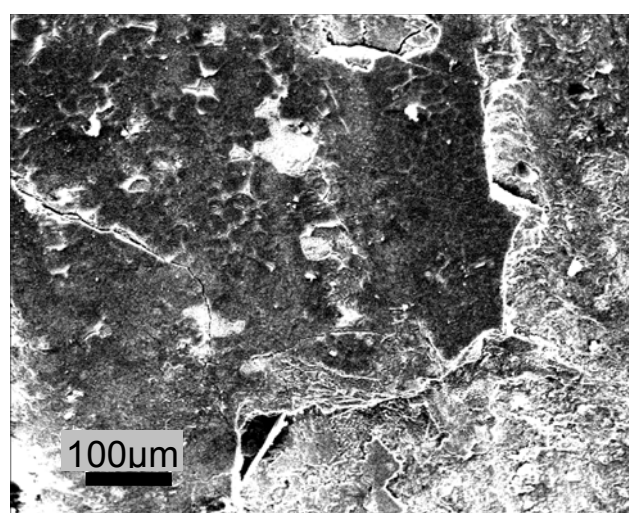
Depth of wedge-shaped formation varies from several tens of micrometers to 2–3.8 millimetres. Width of the wedge is several micrometers and often admits in the range of grain size. Small grey wedge-shaped insertions are generally homogeneous at the surface of rod (Fig. 1, a), but black colour areas are observable in deeper insertions (Fig. 2, a, c), showing that metallic material is changed by non-metallic insertions. Black insertions are also visible at the dividing line between the main metal and grey formations or can locate as series of small black insertions in the grey one (Fig. 1). There was assumption, that lightning discharge affected this part of specimen more than one time. Especially clear black dividing line between the main metal and grey formation is observable in the specimen made from bottom part of armature rod lied in the foundation of reinforced concrete. Deep grey formation with centres of fragmentation is apparent (Fig. 3). Investigating by electron scanning microscope SEM EVO 50, micro cracks and separate white non-metallic zones were detected (Fig. 4).

Fig. 4. Microstructure of surface of armature rod No 1 affected by lightning discharge picked up by electron scanning microscope SEM EVO 50. Cracks and metal formations are black, non-metal formations – white

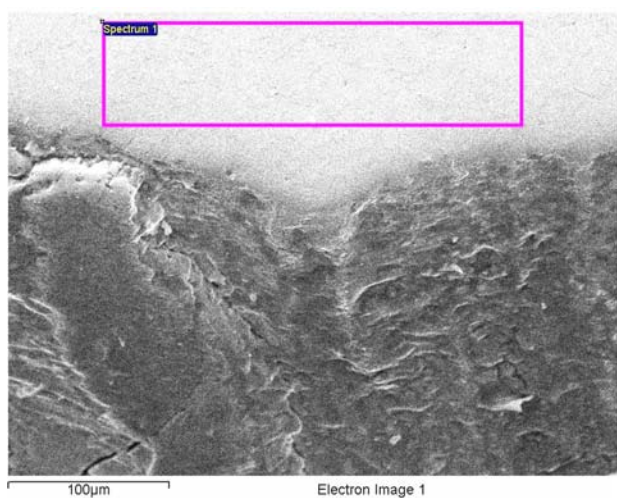
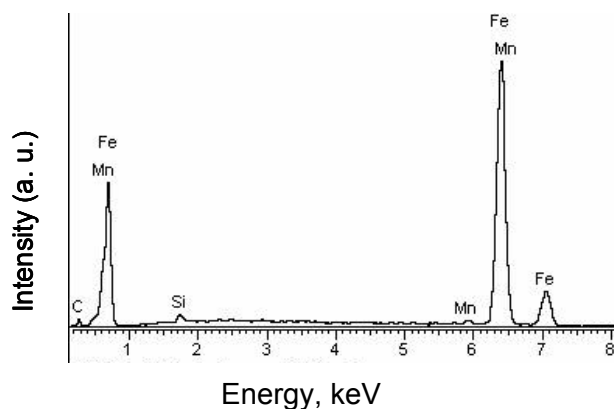
Analyzing element composition by INCAx-sight EDS in 200 μm² zone of unchanged microstructure, which locates about 50 μm from the zone affected by lightning discharge (Fig. 5, Table 1) carbon amount was found 4.3 %. Determining element composition of the 500 μm² affected zone (Fig. 6, Table 2) that locates approximately 90 μm from the dividing line, amount of carbon has increased up to 17.49 %. Content of silicon and manganese changed fractionally near the affected zone.

Fig. 5. Influence of lightning discharge on chemical composition of at the surface armature steel rod No 1: a – zone of spectrum analysis; b – spectrum analysis of elemental composition of the main metal. SEM EVO 50 (chemical composition is presented in Table 1)

Elements	C	Si	Mn	Fe
Weight %	4.3 (0.27*)	0.80 (0.73*)	0.94 (1.05*)	93.96
Atomic composition, %	17.16	1.36	0.82	80,65

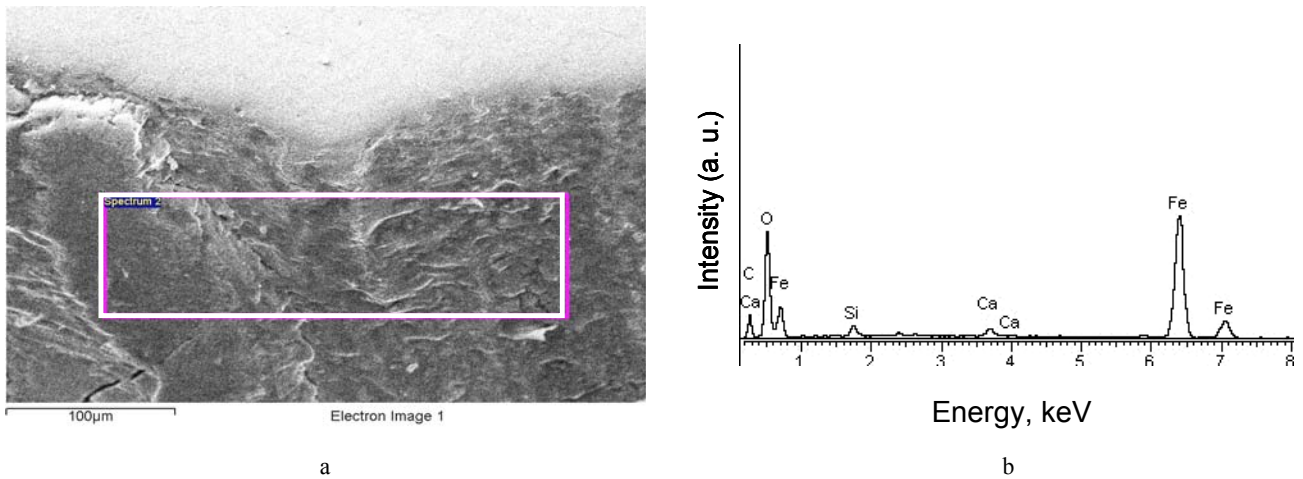
This formation contains also oxygen (26.32 weight percent), calcium (1.06 weight percent), an amount of silicon has increased from 0.73 % until 1.07 %, but manganese has disappeared (Table 2).

Fig. 6. Influence of lightning discharge on chemical composition of at the dividing line between main metal and affected zone (rod No 1): a – zone of spectrum analysis; b – spectrum analysis of elemental composition of the main metal. SEM EVO 50 (chemical composition is presented in Table 2)

Elements	C	O	Si	Mn	Ca	Fe
Weight %	17.49	26.32	1.07	–	1.06	54.06
Atomic composition, %	35.23	39.79	0.92	–	0.64	23.42

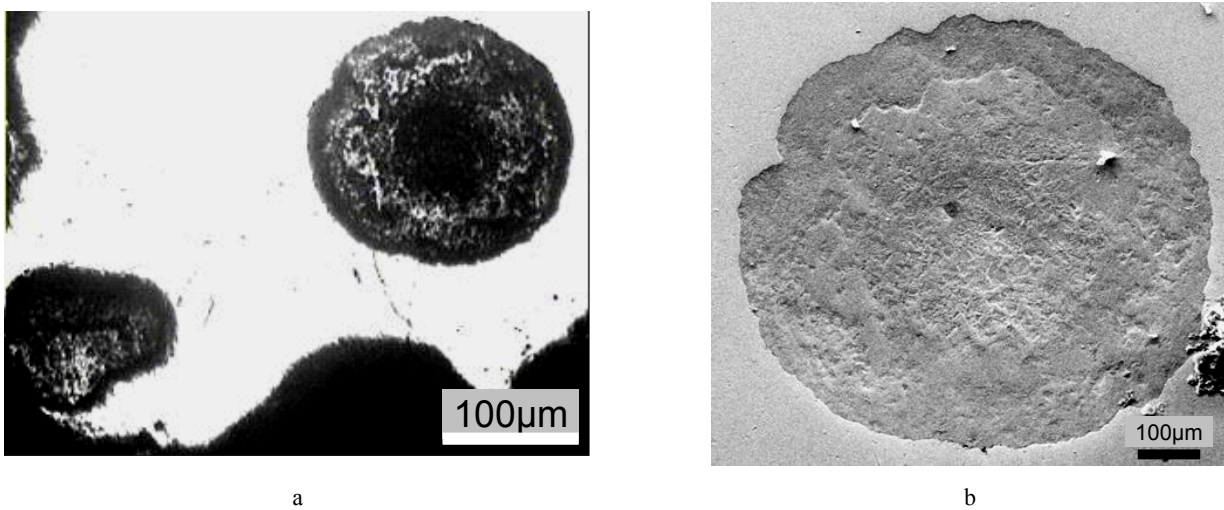
Cylindrical formation as 700 μm diameter circle and located about 300 μm from the surface was dedicated (Fig. 7). Distribution of its chemical composition was determined and is listed in Table 3. There was no carbon found near this formation. Itself it has contained decreasing amount of carbon – from 5.57 % till 6.90 %. This formation has not contained magnesium, although the investigated steel has 1.10 % Mn.

Fig. 7. Surface structure of specimen rod No 2 affected by lightning discharge observing by optical microscope (a) and by SEM EVO-50 (b)

Location	C	O	Si	Mn	Cr	K	Ca	Fe
520 µm from the centre of formation	–	–	0.65	1.41	–	–	–	97.94
390 µm from the centre of formation	5.57	34.32	1.38	–	–	0.97	0.65	57.11
280 µm from the centre of formation	6.01	34.70	1.04	–	–	0.59	–	57.27
Centre of formation	6.90	33.59	1.77	–	0.86	1.20	0.68	54.99
