## Laser Treatment of PVD Coated Carbon Steels and Powder Steels

Andrei SURZHENKOV<sup>1\*</sup>, Priit KULU<sup>1</sup>, Andre GREGOR<sup>2</sup>, Petri VUORISTO<sup>2</sup>,  
Jyrki LATOKARTANO<sup>2</sup>, Mikko RUPPONEN<sup>2</sup>

In the present study, the opportunities of laser beam treatment by the means of the 4 kW Nd:YAG laser are investigated. The studied materials are carbon steels C 45 and C22E (carburized), coated with the PVD coatings Ti(C,N), TiN and (Al,Ti)N, and powder steel Vanadis 6. The macrophotos of the laser beam treated surfaces were taken, the microstructures of the cross-sections of laser beam treated specimens were studied, and the microhardness profiles of the cross-sections of laser beam treated specimens were made. As these studies have shown, no signs of the influence of laser beam appear at the surface of the PVD coatings, until an energy input threshold is reached, after that the coating oxidizes and degrades. No hardened zones were found under the PVD coatings, except for (Al,Ti)N coating. In the case of steel Vanadis 6, three distinct zones can be seen. In the first zone, the carbide particles have dissolved, and a dendritic structure has appear

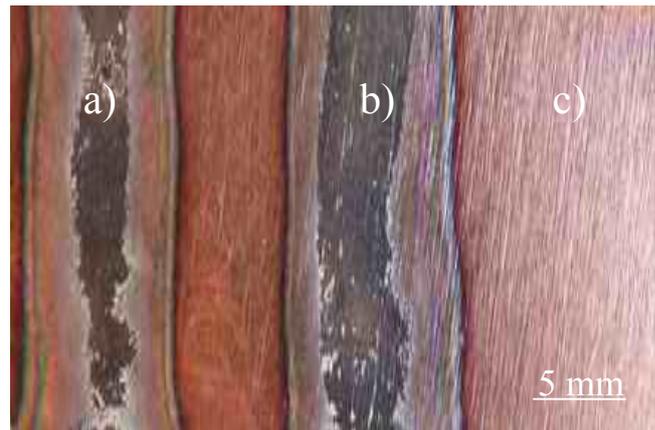
**Fig. 2.** The surface of laser beam treated Ti(C,N) coating, carried onto the carburized steel C22E. Scan speed 300 mm/min, laser beam power values: a) 710 W; b) 650 W; c) 600 W

In the case of PVD coatings, no visible changes of the surfaces' conditions were noticed. However, when a certain threshold of energy input is exceeded, the coating is oxidized and removed from the substrate. Fig. 2 illustrates this case for the TiCN coating on carburized steel C22E.

In this case, three single passes at laser beam power values of 710 W, 650 W and 600 W (at Fig. 2, a, b and c respectively) at the constant speed of 300 mm/min were applied to the specimen. As it can be seen, degradation of the coating takes place in the middle of the laser beam treated zone. This can be explained by the different expansion coefficients of Ti(C,N) coating and the

substrate. At the expense of that tensile stresses appear in the coating that leads to its degradation. Apart from that, the austenite-to-martensite transformation can be also partially responsible for the destruction of the coating, as the martensitic structure was found in the coating-free treated zone of the specimen, and the austenite-to-martensite transformation is followed by the size alterations.

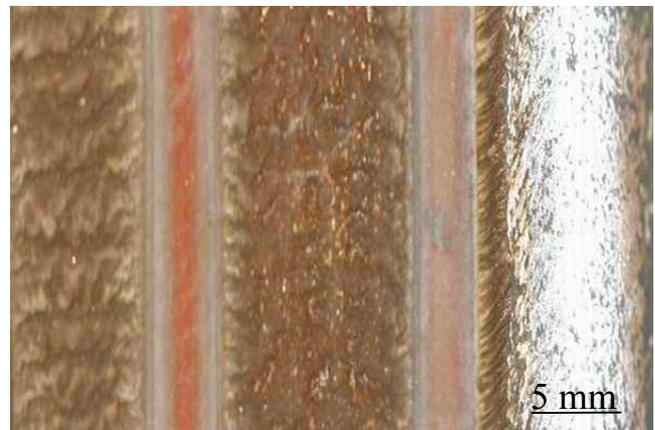
**Fig. 3.** The surface of laser beam treated steel Vanadis 6. Scan speed 300 mm/min, laser beam power 1000 W

Fig. 3 represents the laser beam treated surface of steel Vanadis 6, where all three passes were completed, applying the final set of parameters. In this case, the surface melted significantly, whereas, as it can be seen, there is a clearly distinct border between the laser beam treatment zone and the surface, left untreated. In addition to that, it can be seen that at one edge the specimen has melted in a more dramatic way. The possible explanation for it is that the more melted zone appeared during the last pass, made by laser. In such case, the specimen is heated to a bigger extent, than at the beginning of treatment, thus the temperature in the zone of the third pass is higher.
