## Laser Treatment of PVD Coated Carbon Steels and Powder Steels

In the present study, the opportunities of laser beam treatment by the means of the 4 kW Nd:YAG laser are investigated. The studied materials are carbon steels C 45 and C22E (carburized), coated with the PVD coatings Ti(C,N), TiN and (Al,Ti)N, and powder steel Vanadis 6. The macrophotos of the laser beam treated surfaces were taken, the microstructures of the cross-sections of laser beam treated specimens were studied, and the microhardness profiles of the cross-sections of laser beam treated specimens were made. As these studies have shown, no signs of the influence of laser beam appear at the surface of the PVD coatings, until an energy input threshold is reached, after that the coating oxidizes and degrades. No hardened zones were found under the PVD coatings, except for (Al,Ti)N coating. In the case of steel Vanadis 6, three distinct zones can be seen. In the first zone, the carbide particles have dissolved, and a dendritic structure has appeared. In the second zone, the carbide particles remained, however, they were of smaller size in comparison with the initial structure. In the third zone, the initial structur

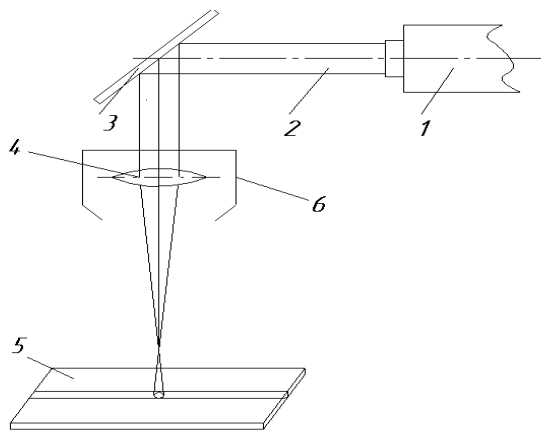
**Fig. 1.** The principle scheme of laser beam treatment: 1 – laser, which is operated in a pulsed or continuous wave mode, 2 – laser beam, 3 – turning mirror, 4 – optical system, 5 – specimen, 6 – nozzle for the gas feed

Laser beam treatment was performed using the Haas HL4006D 4 kW Nd:YAG laser with the wavelength of 1064 nm. The laser was operated in the CW mode, the dimensions of a laser spot were set as 4 mm × 9 mm. Treatment zone was shielded with argon at the flow rate of 20 l/min. Three passes without overlapping were applied to each specimen, treated at final sets of parameters. The principle scheme of a laser beam treatment is presented by Fig. 1. The final treatment parameters are brought at Table 2.

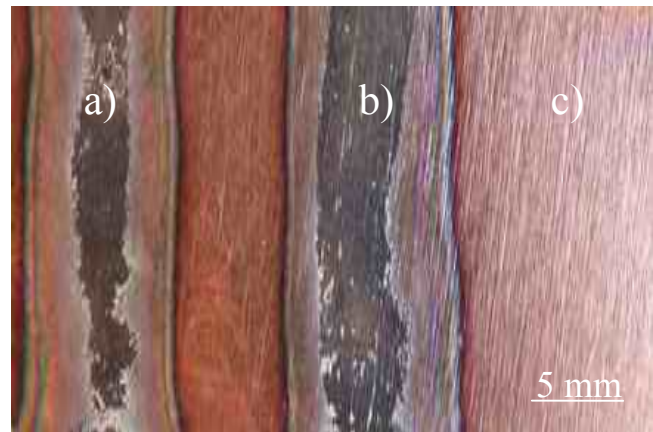
**Fig. 2.** The surface of laser beam treated Ti(C,N) coating, carried onto the carburized steel C22E. Scan speed 300 mm/min, laser beam power values: a) 710 W; b) 650 W; c) 600 W

In the case of PVD coatings, no visible changes of the surfaces' conditions were noticed. However, when a certain threshold of energy input is exceeded, the coating is oxidized and removed from the substrate. Fig. 2 illustrates this case for the TiCN coating on carburized steel C22E.

In this case, three single passes at laser beam power values of 710 W, 650 W and 600 W (at Fig. 2, a, b and c respectively) at the constant speed of 300 mm/min were applied to the specimen. As it can be seen, degradation of the coating takes place in the middle of the laser beam treated zone. This can be explained by the different expansion coefficients of Ti(C,N) coating and the

substrate. At the expense of that tensile stresses appear in the coating that leads to its degradation. Apart from that, the austenite-to-martensite transformation can be also partially responsible for the destruction of the coating, as the martensitic structure was found in the coating-free treated zone of the specimen, and the austenite-to-martensite transformation is followed by the size alterations.

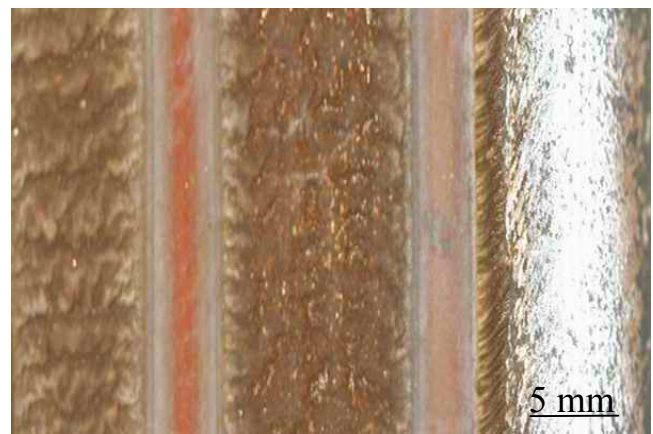
**Fig. 3.** The surface of laser beam treated steel Vanadis 6. Scan speed 300 mm/min, laser beam power 1000 W

Fig. 3 represents the laser beam treated surface of steel Vanadis 6, where all three passes were completed, applying the final set of parameters. In this case, the surface melted significantly, whereas, as it can be seen, there is a clearly distinct border between the laser beam treatment zone and the surface, left untreated. In addition to that, it can be seen that at one edge the specimen has melted in a more dramatic way. The possible explanation for it is that the more melted zone appeared during the last pass, made by laser. In such case, the specimen is heated to a bigger extent, than at the beginning of treatment, thus the temperature in the zone of the third pass is higher.

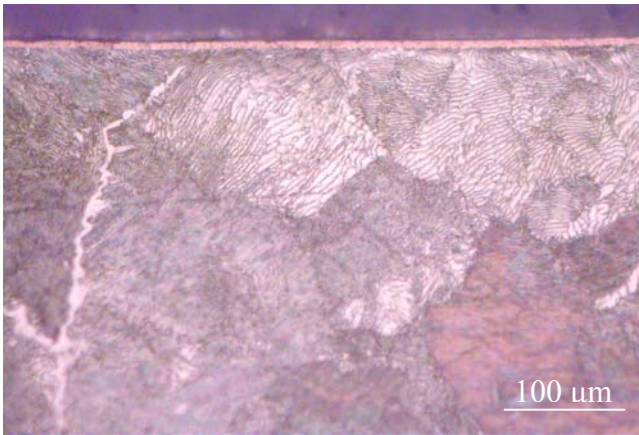
**Fig. 4.** Microstructure of laser beam treated carburized steel C22E, coated with the Ti(C,N) coating. Scan speed 300 mm/min, laser beam power 600 W

Figs. 4 and 5 show the laser beam treated zones of carburized steel C22E specimens, which were coated with Ti(C,N) and (Al,Ti)N coatings, respectively. As it can be seen, no visible effect of treatment is present. The possible reason for it is that the temperature under the coating didn't exceed the phase transformation temperature.

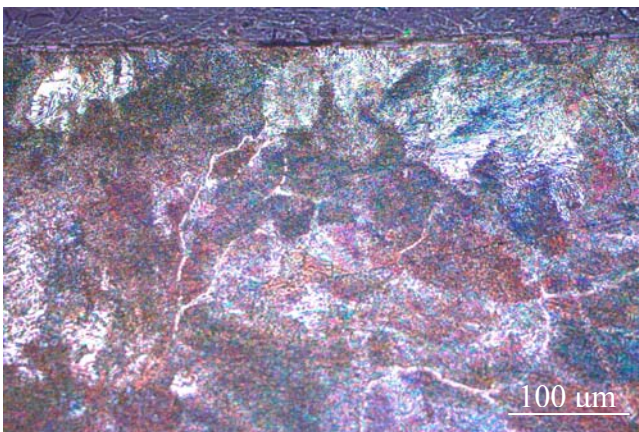
**Fig. 5.** Microstructure of laser beam treated carburized steel C22E, coated with the (Al,Ti)N coating. Scan speed 300 mm/min, laser beam power 500 W

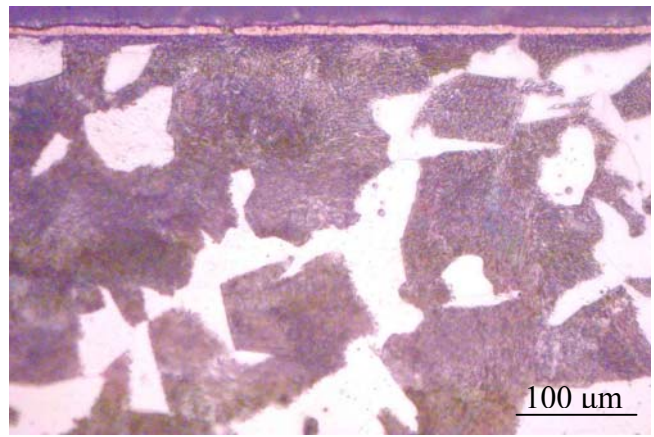
**Fig. 6.** Microstructure of laser beam treated steel C 45, coated with the Ti(C,N) coating. Scan speed 300 mm/min, laser beam power 600 W

Figs. 6 and 7 illustrate the laser beam treated zones of steel C 45, coated with Ti(C,N) and TiN PVD coatings, respectively. Neither in the first case nor in the second one any signs of phase transformation could be seen. The possible reason for it is that the phase transformation temperature has not been reached.

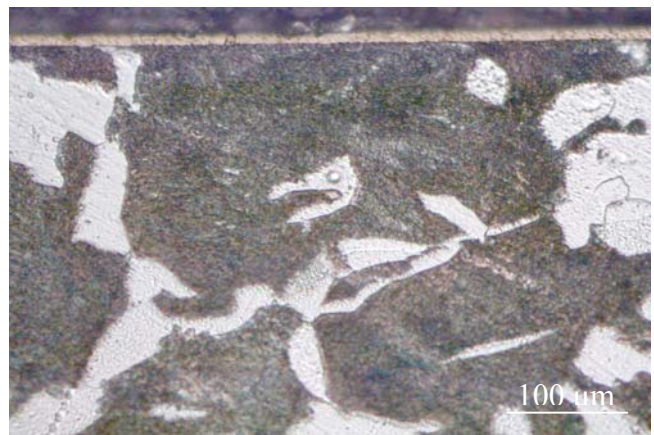
**Fig. 7.** Microstructure of laser beam treated steel C 45, coated with the TiN coating. Scan speed 300 mm/min, laser beam power 500 W

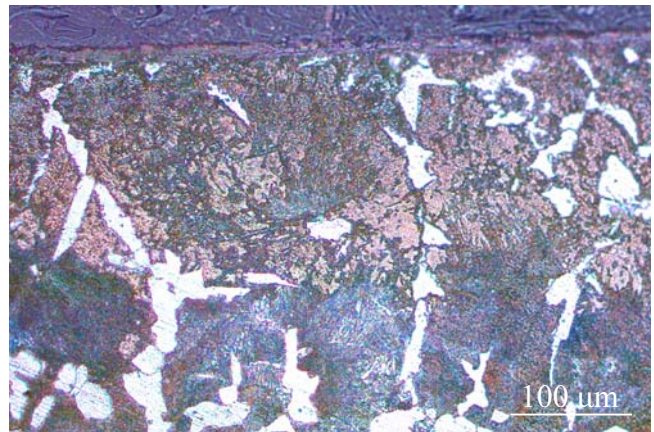
**Fig. 8.** Microstructure of the laser beam treated steel C 45, coated with the (Al,Ti)N coating. Scan speed 300 mm/min, laser beam power 500 W

Fig. 8 illustrates the structure of the laser beam treated steel C 45, coated with the (Al,Ti)N coating. The presence of small amounts of martensite can be seen. Such small amounts of martensite can be explained by an insufficient heating during the treatment. The reason, why such effect has not found place in the case of carburized steel C22E, can be the relatively large grains, which were not heated enough for the martensitic structures to appear.

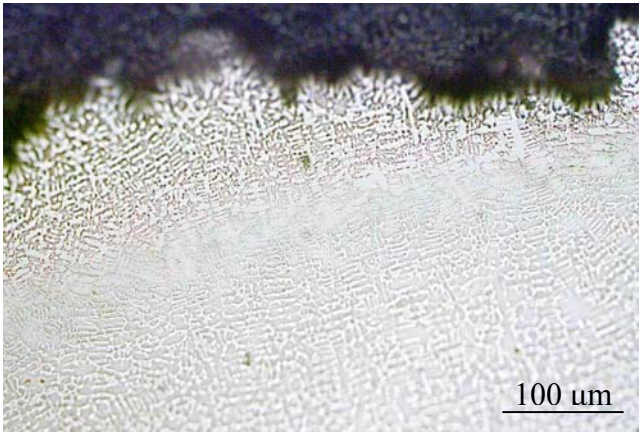
**Fig. 9.** Microstructure of the laser beam treated steel Vanadis 6. The first zone of the laser beam affected area. Scan speed 300 mm/min, laser beam power 1000 W

Figs. 9 and 10 represent the microstructure of laser beam treated steel Vanadis 6. As it can be seen, two zones can be distinguished in the laser beam affected area. The first one, which is situated near the surface of the specimen, has a dendritic eutectic two-phase structure, whereas dendrites are mostly situated perpendicular to the direction of heating. This shows that in this case heat spreads rather by heat conductivity than by convection.

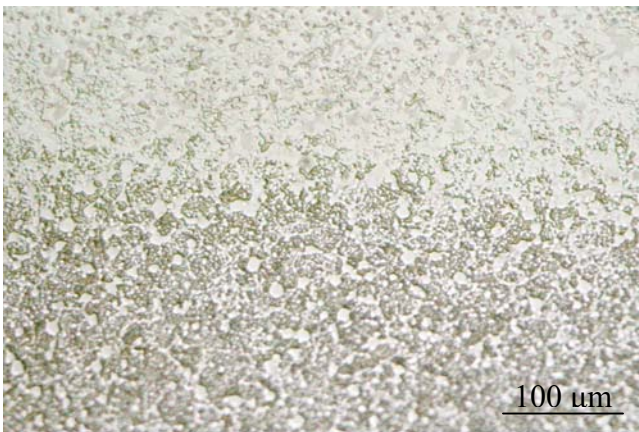
**Fig. 10.** Microstructure of the laser beam treated steel Vanadis 6. The second zone of the laser beam affected area. Scan speed 300 mm/min, laser beam power 1000 W

The second zone, situated near the untreated material, has a structure of the eutectic two-phase matrix with the dispersed carbide particles, whereas the latter are smaller than in the untreated material.

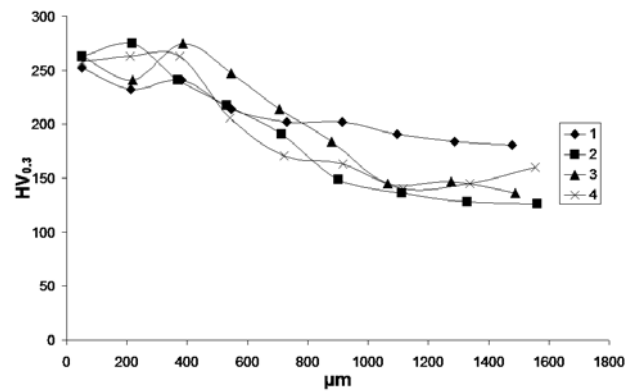
**Fig. 11.** The microhardness profiles of laser beam treated steel C22E specimens with PVD coatings: 1 – Ti(C,N), 2 – (Al,Ti)N, 3 – Ti(C,N), untreated, 4 – (Al,Ti)N, untreated

Fig. 11 represents the microhardness profiles of the cross-section of steel C22E laser beam treated specimens, coated with the Ti(C,N) and (Al,Ti)N coatings. In comparison, the microhardness profiles of the cross-sections of the untreated steel C22E specimens with the same coatings are brought.

As it can be seen, no hardening effect has found place. This can be explained by the insufficient heating by the laser beam.

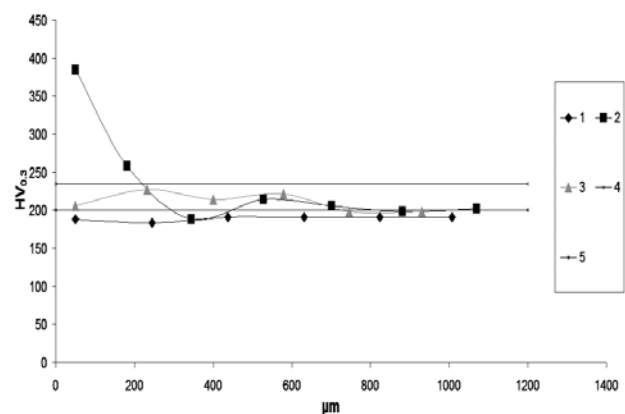
**Fig. 12.** The microhardness profiles of the laser beam treated steel C 45 specimens with the PVD coatings: 1 – Ti(C,N), 2 – (Al,Ti)N, 3 – TiN, 4 – C 45, untreated, maximal microhardness, 5 – C 45, untreated, minimal microhardness

Fig. 12 shows the microhardness profiles of the cross-section of the laser beam treated steel C 45 specimens, coated with the coatings Ti(C,N), (Al,Ti)N and TiN coatings. In addition to them, the two horizontal lines illustrate the maximal and minimal microhardness values, obtained in the steel C 45 untreated specimens.

As it can be seen, except for the specimen, coated with the (Al,Ti)N coating, where a hardened zone of about 200 μm appeared, no hardening effect can be seen. The possible reason for it is that the phase transformation temperature has not been reached in the majority of cases.

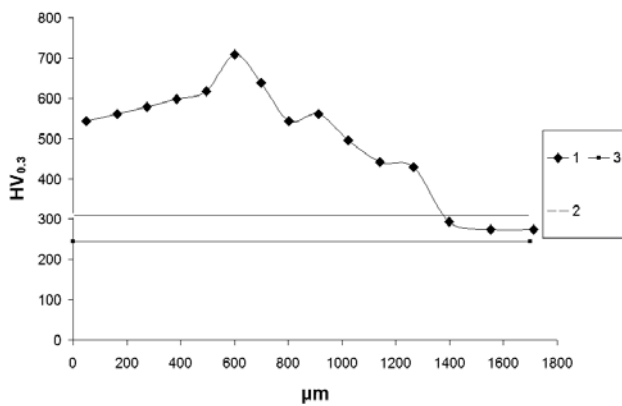
**Fig. 13.** The microhardness profile of the laser beam treated steel Vanadis 6 specimen: 1 – microhardness profile of the laser beam treated zone, 2 – steel Vanadis 6, untreated, maximal microhardness, 3 – steel Vanadis 6, untreated, minimal microhardness

Fig. 13 represents the microhardness profile of the cross-section of the laser beam treated steel Vanadis 6.

As it can be seen, the depth of the hardened zone reaches 1400 μm, whereas the maximal microhardness value is approximately at the depth of 600 μm. Such distribution of the microhardness values can be explained by the fact that the microhardness of the eutectic, what formed at the top of the laser beam affected zone, has lower microhardness values than the structure in the middle of the laser beam affected zone. In its turn, it can be explained by the dissolution of carbides at the top of the laser beam affected zone, and the appearance of more

dispersed carbides at the lower part of the laser beam affected zone.
