Carbonation of Alumina Cement-bonded Conventional Refractory Castable in Fireplace

Ina PUNDIENĖ*, Stasys GOBERIS, Valentin ANTONOVIČ,
Rimvydas STONYS, Algimantas ŠPOKAUSKAS

Vilnius Gediminas Technical University of Thermal Insulation, Linkmenų 28, LT-08217 Vilnius, Lithuania

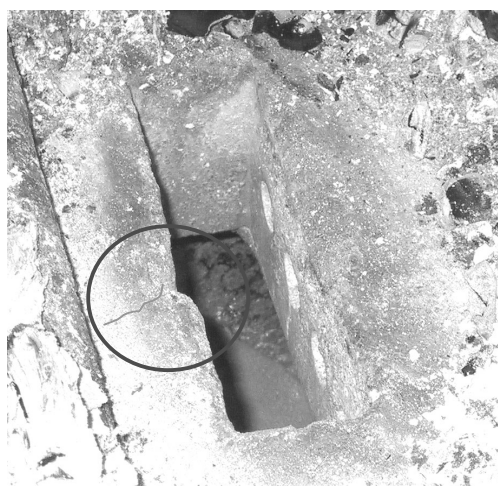
Practical observation showed, that alumina cement-bonded castable blocks of boilers that are heated by biofuel disintegrate and fracture (Fig. 1).

Fig. 1. Examples of castable products destruction in boiler (size $(40 \times 20 \times 5) \text{ cm}$ and $(60 \times 40 \times 10) \text{ cm}$)

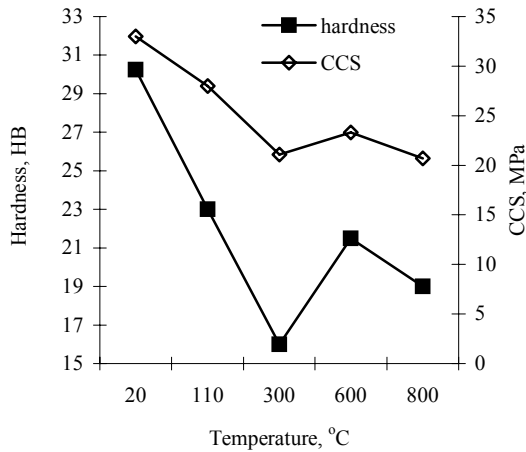
The hardness of the castable fired at laboratory conditions depending on the temperature might reach up to $15 \text{ HB} - 30 \text{ HB}$. As it might be noticed (Fig. 2) temperature negatively affects the hardness of the castable: after heating at $110 \text{ }^\circ\text{C} - 800 \text{ }^\circ\text{C}$ temperatures this value decreases 15% – 45% (it is due to the dehydration). It has

to be noted that the values of the castable's hardness correlate very well with the values of castable's cold crushing strength (Fig. 2). The difference between the values of exploited and not exploited castable hardness showed, that not only temperature but also other factors influence the material destruction during the exploitation. These factors we aimed to reveal in this work.

Fig. 2. The dependence of castable hardness and cold crushing strength (CCS) upon the temperature

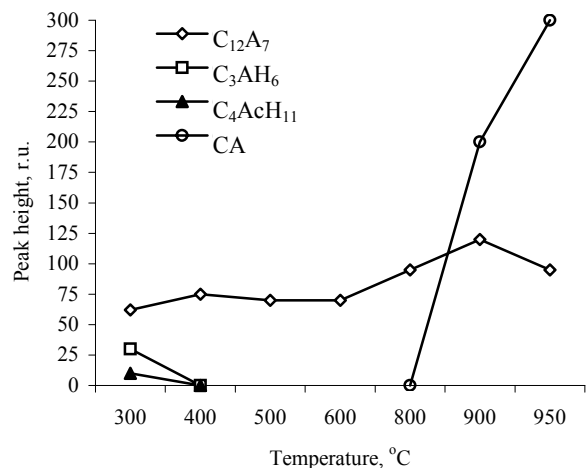
After firing at the interval of 300 °C – 950 °C temperatures minerals $C_{12}A_7$ and CA were determined, and C_3AH_6 was determined only after firing at 300 °C temperature because it disintegrates at the temperature of 360 °C (Fig. 3). The results might be explained by dehydration scheme of cement mineral hydrates [10]:

Amount of $C_{12}A_7$ increased when the specimens were fired at the temperatures 600 °C – 900 °C and decreased after 950 °C. It can be notice that CA intensively crystallizes in the composition after firing at 900 °C.

Fig. 3. Changes of peak height of minerals (C_3AH_6 ($d = 0.229$ nm), $C_{12}A_7$ ($d = 0.220$ nm), C_4AcH_{11} ($d = 0.76$ nm) and CA ($d = 0.297$ nm)) representative peak after firing

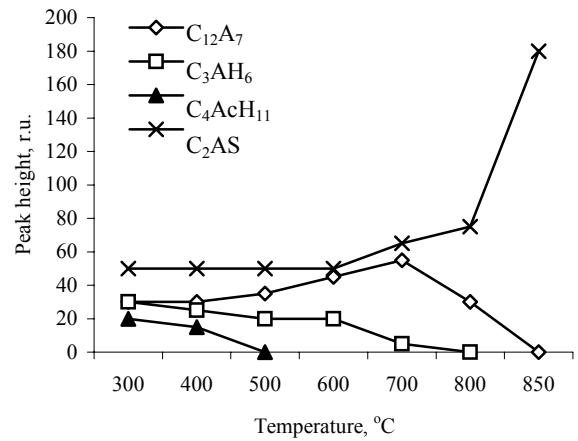
In the specimens cured in humid conditions (Fig. 6) mineral C_3AH_6 forms, but it's amount is smaller than in the specimens of composition A. After firing at 800 °C this mineral is not found any more in the specimens cured in humid conditions.

C_4AcH_{11} mineral has not been identified in the fired specimens, but a small amount of it was found in the specimens that were cured in humid conditions, however, after firing at 500 °C it is not observed (Fig. 6).

Fig. 6. Changes of peak height of minerals (C_3AH_6 ($d = 0.229$ nm), $C_{12}A_7$ ($d = 0.220$ nm), C_4AcH_{11} ($d = 0.76$ nm) and C_2AS ($d = 0.285$ nm) representative peak after firing and curing in humid conditions

After firing at 850 °C $C_{12}A_7$ has not been identified as well as amount of gehlenite considerably increased in any of the specimens (neither in fired nor in cured in humid conditions).
