## Non-Wear Effect on Composite Steel-Brass Surface

The paper deals with the investigation on friction couples sharing one composite surface. The composite friction surface consists of steel 45 and electropulse sprayed brass Л63 coating segments. The investigation objective is to determine the extent of the influence of the ratio of steel to brass coatings areas on the selective transfer effect in this friction surface. In the analysis of the friction surface state the characteristics of the formation of the brass servovite film have been evaluated while varying the areas of steel and brass segments in the friction surface. The latter and the resulting brass film have been analyzed by optical microscope. In the composite surface with no less than 50 % of brass coating segments area the non-wear effect can be achieved. Under 0.6 MPa pressure and 0.72 m/s sliding speed, in a friction couple the servovite film forms in 10...15 minutes. This film reduces the surface roughness from  $Ra$  0.60  $\mu\text{m}$  to  $Ra$  0.10  $\mu\text{m}$ .

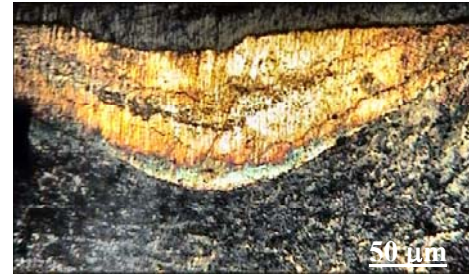
**Fig. 2.** Segment of brass coating on the friction surface (cross section)

After the electropulse coating spray the microscopic analysis of friction surfaces indicated the structure of coatings to be dense. Due to markedly high fluidity and speed of overheated brass particles the coating perfectly filled the surface of the pits formed on the surface area (Fig. 2).

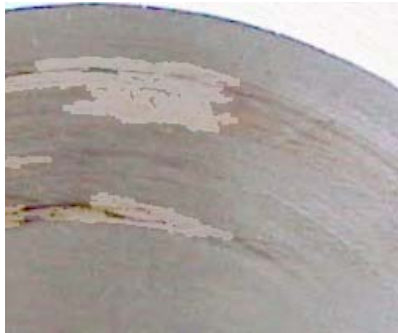
**Fig. 4.** Disk surface after the friction test with 50/50 block: light segments – copper coating (2:1)

50/50 blocks had been working the whole test period of 30 minutes without any vibration. After 18...20 min the temperature of the samples got settled at about  $333 \text{ K}$ . The first 10 min the changes in the lubricant state were being observed – microparticles of brass colour sprang up. The lubricant acquired yellowish brown colour. After 10...15 minutes a reddish discontinuous trace used to appear on the disk friction track (Fig. 4).

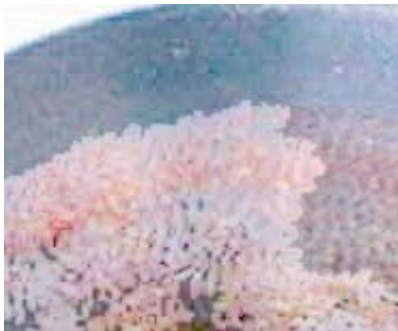
**Fig. 5.** Disk surface after wear test with 0/100 samples: light segments – copper coating (2:1)

When the brass coating was sliding over the disk surface (0/100 block) the friction couple was working smoothly, the blocks surface was being coated by the brass layer which after 5...10 min got reddish – the disk friction surface got coated by a thin copper layer (Fig. 5).

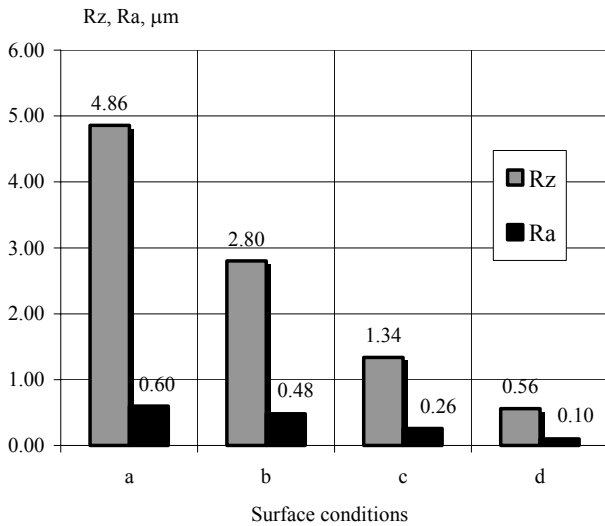
**Fig. 8.** Disk surface roughness dependence on block surface conditions: a – disk before experiment; b – friction couple with block 80/20; c – with block 0/100; d – servovite copper film

The microscopic analysis of friction surfaces and roughness measurements indicated that the created copper colour film is considerably smoother than the initial surface of both the disk and the block (Fig. 8).
