Analysis of the Low Service Life of a Planing Knife – A Case Study

The presented work deals with an analysis of causes of the very low service life of the new version of hand woodworking planing knife, which has replaced the original version of a planing knife. Based on the performed experimental works, chemical analysis, macroscopic and microscopic observation, SEM, diffractometric analysis, and Vickers hardness test it was concluded that the cause for the very low service life (practically the nonexistent one) of the new version of a planing knife are significant features of overheating. During the heating to the hardening temperature used steel was overheated, the cementite carbides dissolved, and the austenitic grains became coarse. The final microstructure of the used steel after hardening and tempering consists of brittle coarse martensitic needles, without any presence of the fine globular cementite carbides, accompanied by a very high amount of retained austenite. Thus, the chipping of the knife's cutting edge took place and the planer was unusable.

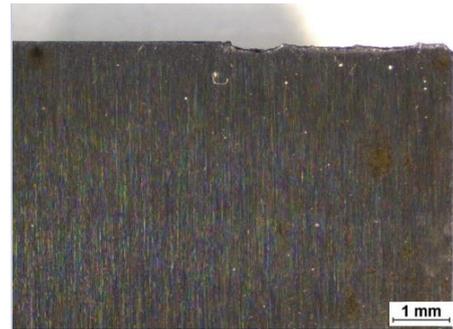
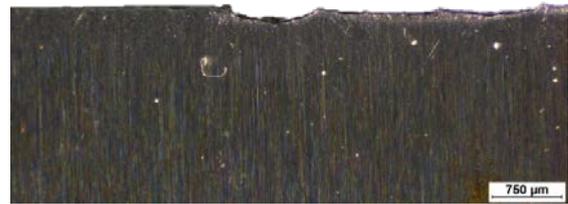
Fig. 3. Planing knife, new version: a – chipping of the cutting edge; b – detail of chipping

The original version of the planing knife has been used reliably for more than three years and no degradation mechanisms have been recorded. The knife has been only regularly sharpened to the desired sharpness. The planing knife of the new version immediately after the first use showed the damage due to the chipping of the cutting edge.

The chip size of the cutting edge ranged from 0.21 mm to 0.92 mm, Fig. 3.

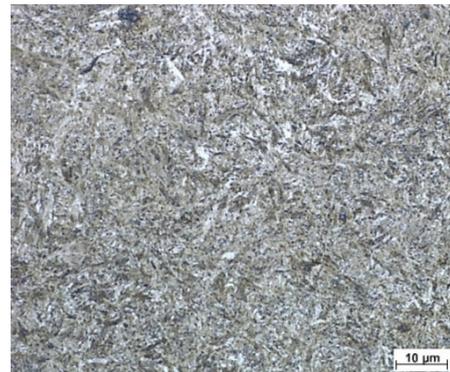
Fig. 5. Microstructure of planing knives: a, c – original version (steel marked as B in Fig. 1); b, d – new version (steel marked as C in Fig. 1), etc. 0.5 % Nital

Microstructures of the planing knives are shown in Fig. 5.

The microstructure of the original planing knife (Fig. 5 a, c, marked as steel B) consists of the fine needles of low-tempered martensite, very fine globular cementite carbides, and retained austenite. The microstructure corresponds to a suitably chosen procedure of heat treatment, hardening and low tempering. The microstructure of the new version of the planing knife (Fig. 5 b, d, marked as steel C) consists of the coarse needles of martensite, accompanied by increased amount of retained austenite. The coarse martensitic microstructure is very brittle. During the heating to the hardening temperature, the steel was overheated, the fine cementite carbides dissolved, and the austenitic grain became coarse [12–15].

3. During the heating to the hardening temperature, the steel of the new planing knife was overheated, the cementite carbides dissolved and the austenitic grains became coarse. The microstructure consists of coarse martensitic needles without any presence of the fine globular cementite carbides, accompanied by a very high amount of retained austenite. Such a coarse martensitic microstructure is very brittle and chipping of the knife's cutting edge took place very easily.
