Experimental Investigation of Lime Mortar Used in Historical Buildings in Becin, Turkey

Adem SOLAK*

Pamukkale University, Faculty of Architecture and Design, Department of Architecture, 20070, Kinikli/Denizli, Turkey

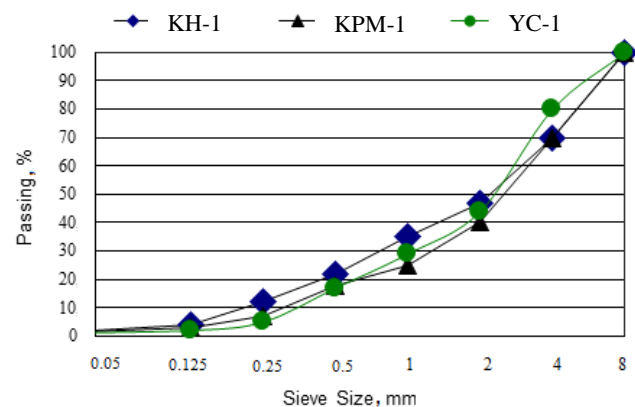
Fig. 4. Results of sieving analysis of the mortar samples 'KH-1, KPM-1, YC-1'

The results of sieving analysis of the mortar samples for the determination of grain size distribution are given in Fig. 4. In all samples maximum aggregate grain size was determined to be 8 mm. Grain size aggregates of more than 1 mm were observed up to 30–50 % of the total aggregate. Findings of Benedetti et al. on Roman time and Oguz et al. on Seljukian structures are similar with the present findings [28, 30].

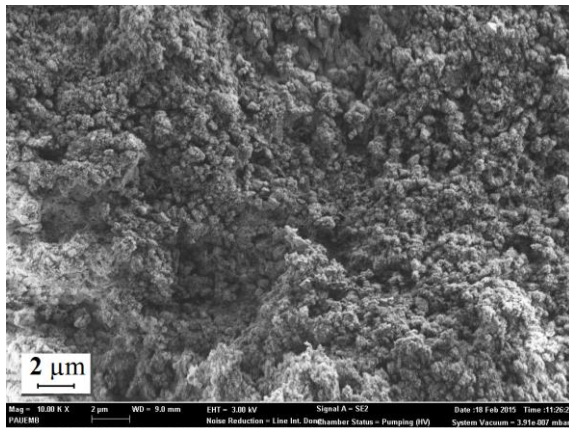
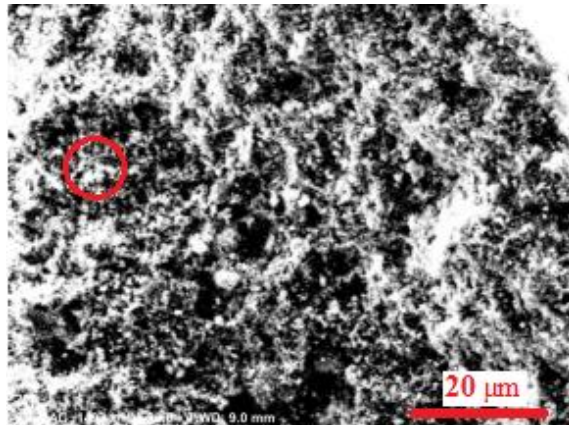
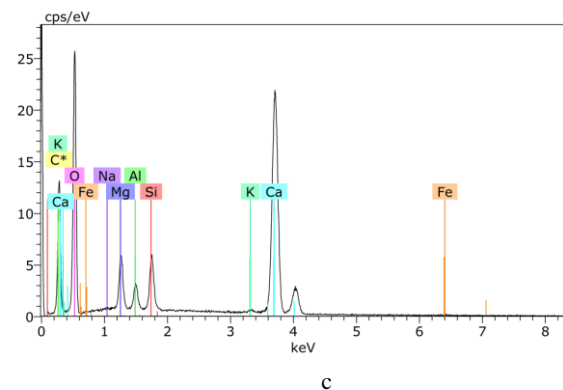
Fig. 5. KPM1 lime SEM/EDS images with magnitude: a – 10.000x for SEM; b – 1.500x for SEM; c – EDS image

Based on SEM, the grain sizes of calcite and other crystals which form lime are determined to be smaller than 4 microns. In addition, grain sizes are almost uniform and homogeneously distributed (Fig. 5 a, b).

EDS analysis also revealed that the Ca has the highest percentage and Mg, Si, Al, K and Fe are present in the lime (Fig. 5 c). The chemical coefficient calculated by the ratio of molecular weight of CaO to atomic weight of Ca was used to convert elemental values such as Ca, Si, etc. from the carbonated lime to oxides ones (CaO, SiO₂, etc.) as indicated in Table 4.

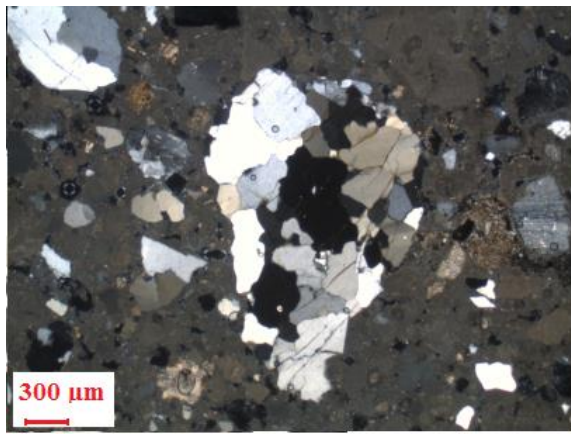
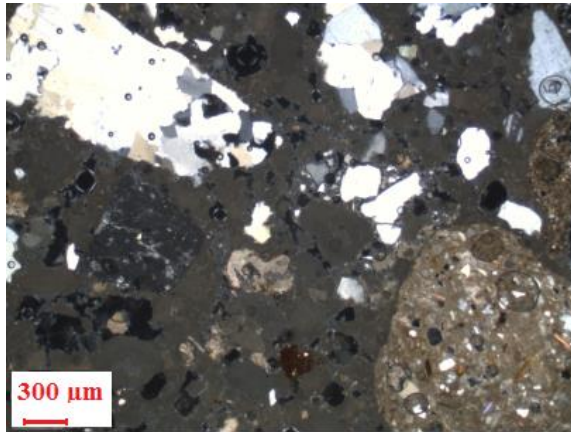
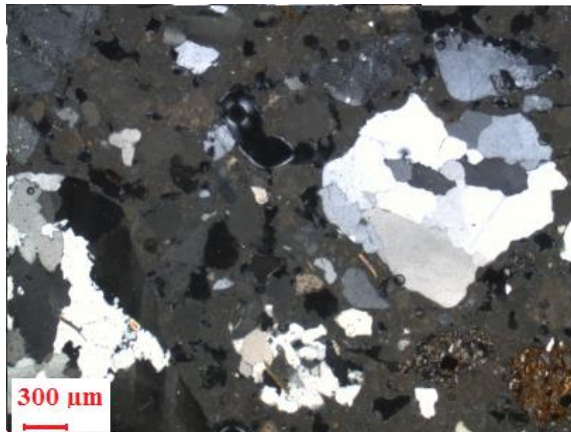
Fig. 6. Polarized microscope views of Kizil Khan mortar: a – general texture; b – binder matrix; c – sandstone

In the petrographic analysis of the Kizil Khan mortar specimens, grain sizes were observed as squared, quartzite partially rounded, mica, feldspar and rarely sandstone grains (Fig. 6 a, b, c) and limestone particles were also observed. In all specimens, the matrix material is fine grain lime. Some pores were observed in the matrix (Fig. 6 b, c).

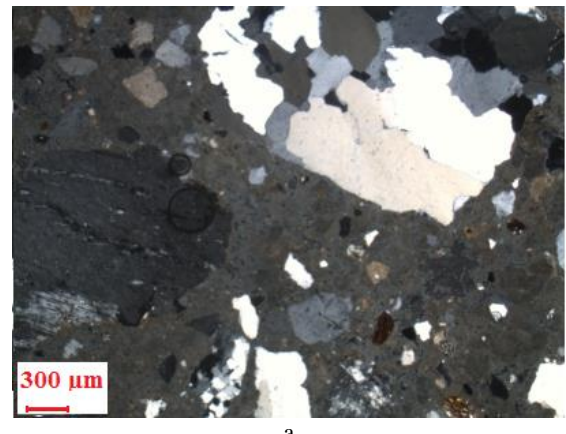
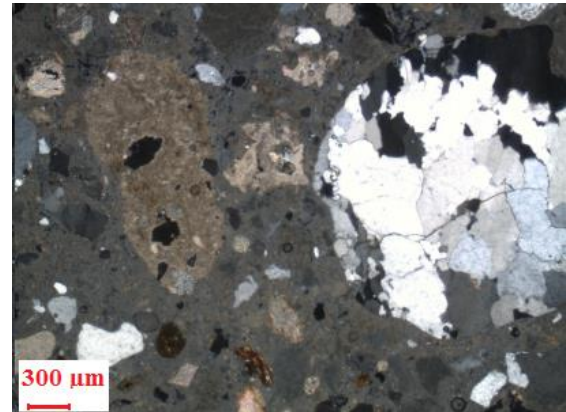
Fig. 7. Polarized microscope views of Yelli Mosque: a, b – general texture

In the petrographic analysis of Yelli mosque specimens, various grain sizes from thin up to large quartzite, mica, feldspar minerals, as well as round micritic limestone particles have been observed. Furthermore, the particles of rocks were determined to have volcanic and metamorphic origins (Fig. 7).

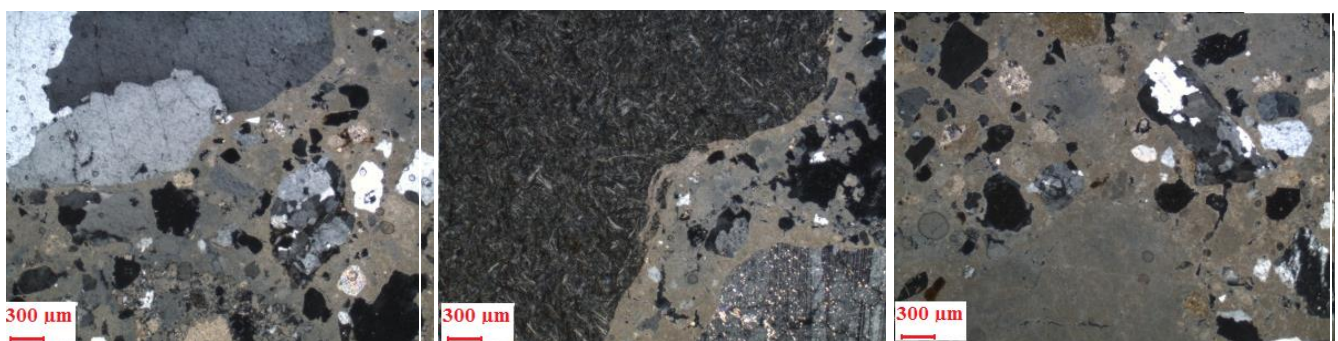
Fig. 8. Microscope views of Karapasah Madrasah material: a – general texture; b – spillitic basalt; c – binder matrix

In the petrographic analysis of Karapasah Madrasah mortar specimens, different sizes and shapes of quartz, quartzite, schist, rarely limestone components (Fig. 8 a) were observed in addition to quite large size piece of rounded basalt syphilitic (Fig. 8 b). It has been determined that lime binder is rather fine-grained and it has plenty of void (Fig. 8 c).

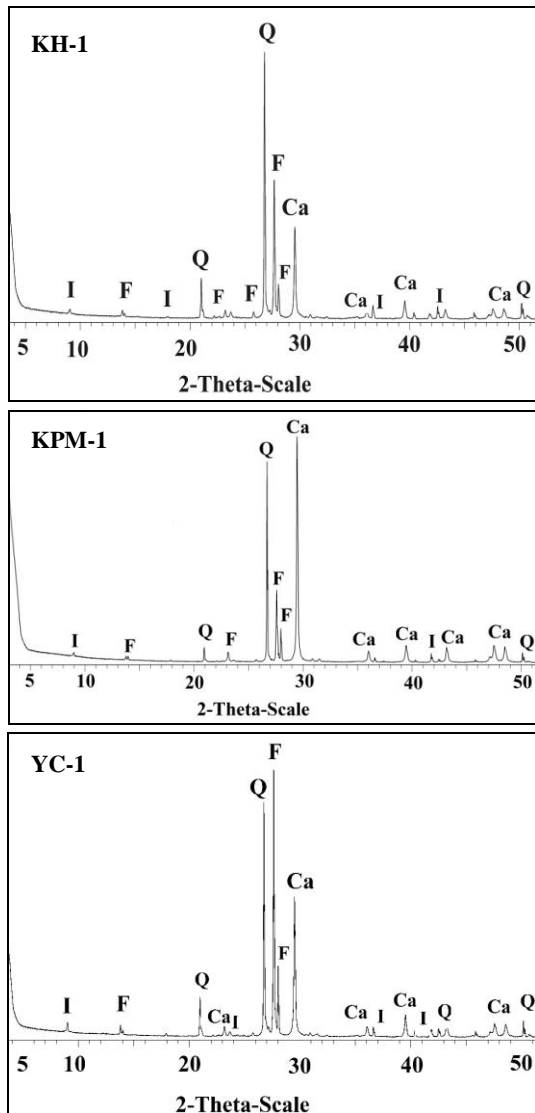
Fig 9. XRD Patterns of Studied Samples KH-1, KPM-1, YC-1 (Q:Quartz, Ca:Calcite, F:Feldspar, I:Illite)

Quartz, Calcite and feldspar minerals were found in the KH-1 and YC-1 samples examined by XRD analysis. Weak peaks of clay minerals and dolomite minerals (only KH-2) have been observed in KH-2, KH-3, KPM-1 and KPM-3 but no calcium silicate hydrate (CSH) was found (Fig. 9 and Table 5). Calcite and dolomite peaks were derived from lime. Quartz and feldspar (albite) represent the aggregates in the mortar. Additionally, it was found by XRD analysis that the feldspar mineral is the albite mineral, which is a $\text{NaAlSi}_3\text{O}_8$ component. Milas district was composed of albite stratum [35] and confirmed the finding of albite mineral in the samples analyzed by XRD tests. Mineralogical structure obtained from the analysis are similar to related literature findings [31, 32].

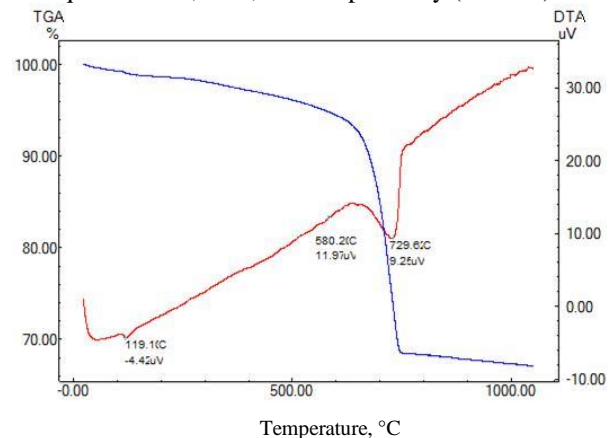
Fig. 10. KPM-1 mortar sample TGA/DTA graph

Percent mass loss of mortars as a function of temperature change at certain temperature intervals have been determined by using TGA/DTA analysis. Samples have been heated up to 1050 °C and endothermic reactions have been evaluated (Fig. 10). Average CO₂/ H₂O ratios of the mortar samples from Kızılhan, Karapasa and Yelli Mosque are 4.58, 6.12, 5.08 respectively (Table 7).
