Analysis of Failure Causes of 0Cr19Ni9 Blade Crack

In this paper, fracture morphology observation, microstructure analysis, standard corrosion test, and other experimental methods are used to analyze the causes of corrosion and cracking of steam turbine blades (0Cr19Ni9) produced by a certain company. The results showed that cracks appeared during the operation of the blade. A large number of dimples were observed under the scanning electron microscope, almost all of which were shear dimples; at the same time, fatigue bands were also distributed in them. The internal cause of the cracks is the long-term service, which causes the carbon and the alloy to undergo a diffusion reaction to form carbon-rich areas and carbides. They are thermally corroded in the service environment, and the carbon-rich zone is reduced, which reduces the strength of the zone; carbides accumulate at the grain boundary, causing groove-shaped defects at the grain boundary to form a cutting effect. It is easy to form a source of fatigue cracks. The external cause is that the material is subjected to transverse stress for a long time during operation, which leads to the generation of cracks. This article analyz

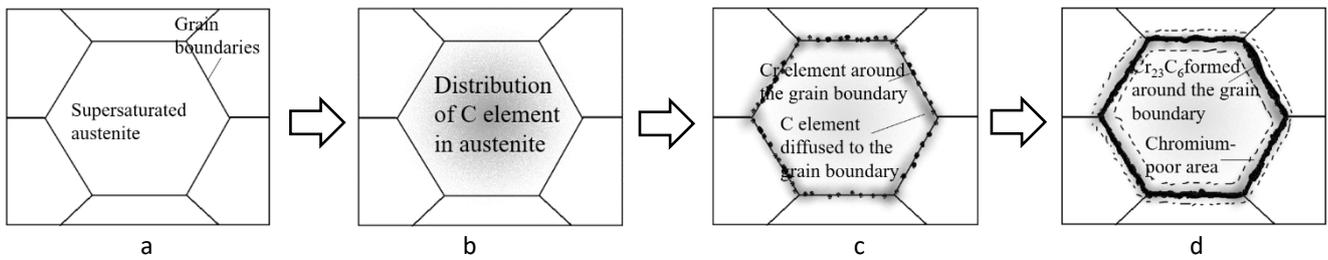
Fig. 10 is a schematic diagram of the evolution of stainless steel intergranular corrosion. The original structure of 0Cr19Ni9 steel is almost 100 % austenite. Due to the high carbon content of the material, all C cannot be dissolved in the austenite. After solution treatment at 1050 °C for 2 h, the excess C can be dissolved in austenite to form a supersaturated solid solution, but the austenite at this time is a metastable phase. If the sample is heated at 400 ~ 850 °C, C will precipitate from the supersaturated γ -Fe solid solution, and rapidly diffuse to the grain boundaries and form precipitated phases with Cr, and precipitate on the grain boundaries to form a network of isolated protrusions. These phases are mainly Cr carbides. The movement rate of Cr in austenitic stainless steel is relatively slow, and it cannot move quickly from the inside of the crystal grain to the part where the Cr content is reduced.

Fig. 10. Demonstration diagram of intergranular corrosion evolution: a–original organization; b–solution treatment; c–C element diffusion; d– Cr_{23}C_6 formation

This causes the Cr content in local areas to be lower than the content of the matrix for a long time, and the grain boundaries are plated with gold to form chromium-poor areas [17]. Since the electrode potential of Cr is higher than that of the austenitic stainless steel, the accumulation of Cr will cause differences in electrode potentials in local areas. When the material is in a corrosive medium, due to the difference in electrode potential of the material, it will lead to differences in the corrosion rate of different parts. Specifically, the corrosion rate near the grain boundaries is higher than that inside the grains, resulting in intergranular corrosion.
