## Study on the Microstructure and Water Absorption Rate Changes of Exterior Thin-layer Polymer Renders During Natural and Artificial Ageing

This paper presents the experimental investigation results of finishing render of external thermal insulation composite systems (ETICS). The study involved natural (long-term) and artificially accelerated (short-term) ageing including effect of UV radiation. The cycle of accelerated UV radiation ageing test, imitating the impact of one natural year in Lithuanian climate conditions, have been used. In order to determine the visual, microstructure and water absorption changes and find out the correlation between the natural and artificial weathering, the results of tested aged and untreated samples have been compared. The main attention was focused on the changes of structure and physical properties after short-term and long-term ageing tests.

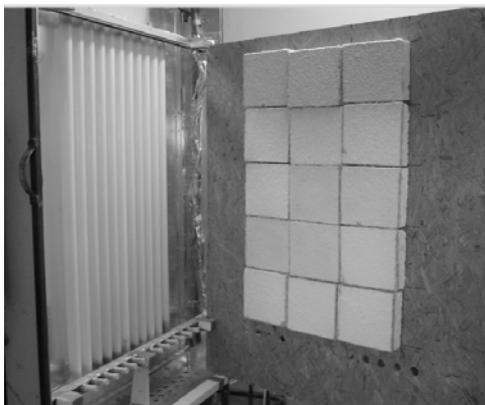
Fig. 1. The prepared ETICS samples for the laboratory testing in the UV climatic chamber

For the short-term ageing each sample was (200×200×50) mm in size. The edges of prepared samples were covered by waterproof epoxy material. Prepared samples were placed in UV climatic chamber (Fig. 1).

The UV radiation impact was imitated using UVA-340 fluorescent lamps (a wavelength from 295 nm to 365 nm). Special lamps were chosen to reproduce the natural solar

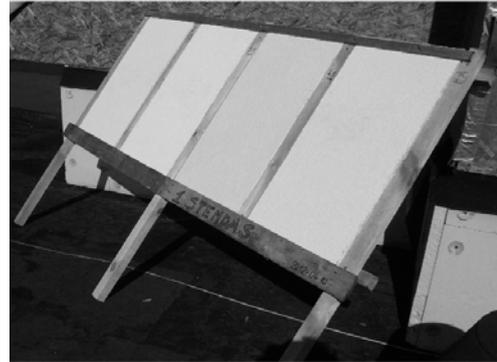
Fig. 2. The ETICS panels (1000×500×50 mm) for the natural ageing placed on the wooden test rack

For the long-term natural ageing the samples of each type of rendering were exposed on a 56° slope of a wooden, South facing rack, placed on the flat roof of a building (Fig. 2). During the natural ageing UV radiation and other climatic impacts were recorded by sensors at the meteorological station of Institute of Architecture and Construction. All prepared ETICS fragments before the experiment were conditioned for 28 days at 60 % ± 5 % relative humidity and 20 °C ± 5 °C temperature environment.

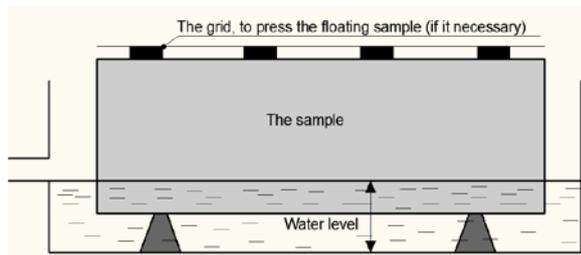
Fig. 3. The scheme of ETICS samples by partial immersion

**Water absorption analysis.** The water absorption rate measurement was performed according to the LST EN standard [18]. It should be noted that the ETIC samples were tested by partial immersion, for not less than 24 hours (Fig. 3).

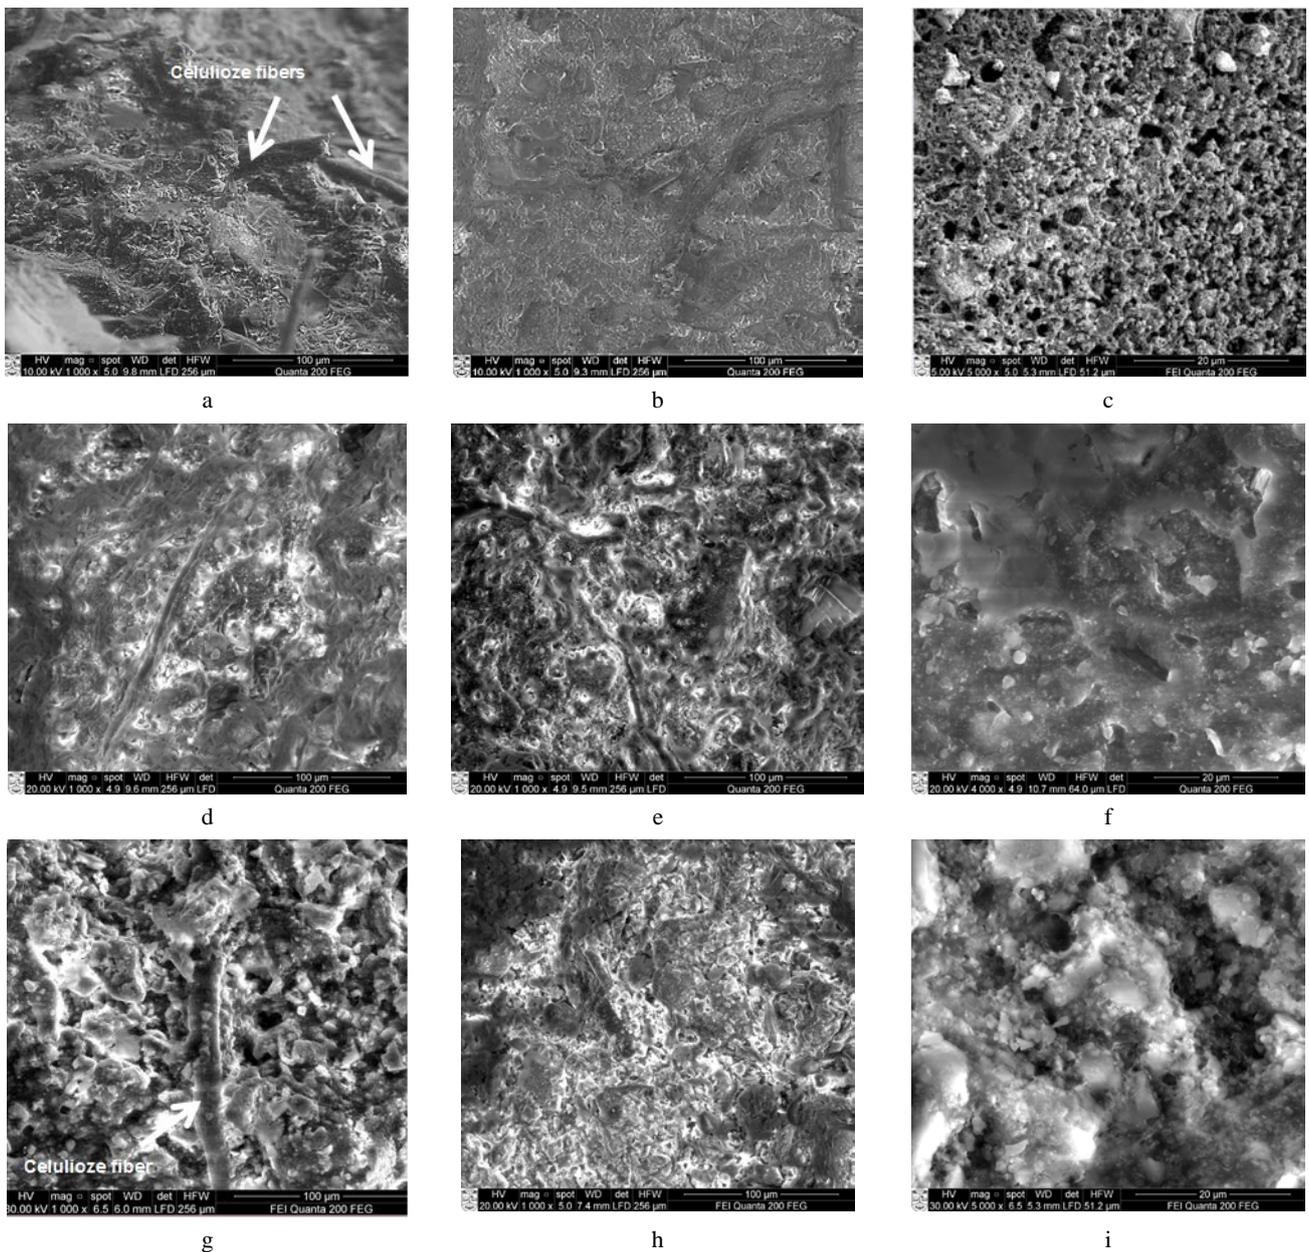
**Fig. 4.** SEM images of exterior polymer renders surfaces before ageing: a – acrylic render, polymer film and cellulose fibers on it are observable; b – silicone render, polymer film on it is observable; c – silicate render, the open pores in render surface are observable. The renders surfaces after one year of natural ageing: d – acrylic render, polymer film disappeared; e – silicone render, polymer film disappeared; crystal materials structure of surface is observable; f – silicate render, pores are covered by crystals. The renders surfaces after artificial UV impact: g – acrylic render, polymer film disappeared, only cellulose fibers and porous structure of surface are observable; h – silicone render polymer film disappeared; i – silicate render, pores are covered by crystals

The microscopic analysis showed the structure changes of polymer renders surfaces. SEM images of surfaces of untreated samples and surfaces of samples after one natural and equivalent laboratory year of exposure to UV radiation with a polymer renders are shown in Figure 4.

First of all, fibrous materials in all render surfaces can be seen clearly. EDS analysis showed that this is an organic compound (C<sub>6</sub>H<sub>10</sub>O<sub>5</sub>)<sub>n</sub>, i.e. cellulose fibers (Fig. 4, a). This fiber improves flexibility, ensures workability and provides deformability of the renders. Also, fibers improve mechanical properties i.e. increase resistance to impacts.

Polymer film structure can be clearly seen on the acrylic (Fig. 4, a) and silicon (Fig. 4, b) render surface. This happened due to the interaction of applied binder and water repelling additive. These two components are used to achieve the formation of polymer film, which covers render pores and capillaries and restricts the surface water absorption of render. Conversely, open pores with various diameters from 1.0 μm to 2.5 μm are visible on silicon render surface in Figure 4, c. Protective polymer film has not formed on the surface of this render, because other binders (liquid potassium silicate makes up the higher part of the binder and styrene-acrylic dispersion – the rest of the material) were used. However, such surface structure ensures good conditions for water vapor permeability and evaporation of absorbed rain water. The drying process has an important role to water content in the whole ETIC system, avoiding the risk of condensation and biological colonization [14].

In order to find out the correlation between the long-term and short-term ageing tests of UV radiation the microstructural changes of renders were compared. Polymer film was not detected on acrylic and silicone render surface in any case of tests (Fig. 4, d, e, g, h). Daniotti carried out an experimental research on finishing coating of ETIC systems and found that the UV is breaking up polymers on the surface of render and increases the render pore size [9]. Thus damaged exterior surface allows the penetration of UV radiation into a deeper layer of render, destroys the polymer chains and reduce water resistance of ETIC system. However, all polymer render

surfaces after both ageing types were coated by crystalline materials which covered a part of the pores and capillaries (Fig. 4, d, e, f, g, h and i), slowing down the destructive effects of UV radiation.

SEM image shows that the amount of open pores in searched area of silicate render was reduced, but the diameter of pores increases after natural and artificial weathering (Fig. 4, f and i). The results of microstructure analyses conform to experimental research of other authors and show that after natural and artificial ageing the open porosity increases in time depending on the type of external coating [2–4]. In our case the largest changes of porosity occurred in silicate and the lowest – in acrylic and silicone renders. Furthermore, such structure ensures better water

drying process [14]. The EDS analysis showed that the main chemical components of the crystalline materials are calcium, magnesium, oxygen and carbon. These compose the chemical compounds – dolomite and calcite ( $\text{CaMg}(\text{CO}_3)_2$  and  $\text{CaCO}_3$ ). The undamaged cellulose fibre is seen on all render surfaces (Fig. 4, g). Surfaces of all types of render look similar after natural and laboratory cycling – it can be stated that the type of degradation is the same.

structure. SEM analysis showed that small diameter (1.5  $\mu\text{m}$ –2.5  $\mu\text{m}$ ) open pores are prevalent on the render surface. Moreover, a polymer film was not formed on the surface (Fig. 4, c) as on acrylic and silicone renders (Fig. 4, a, b). Therefore, ETICS with silicate render can absorb a great amount of water. Initial water absorption rate is lower for samples with acrylic and silicone render. The formed polymeric film on the surface ensured the low water absorption rate and restricted the water absorption into deeper render layers. This protective film has formed not only due to the chosen binder type, but also because of the use of silicone-based water repellent additives. The special silicone-based additive ensures the good vapor permeability and high resistance to water penetration, thereby increasing the exterior coating service life [11, 12].

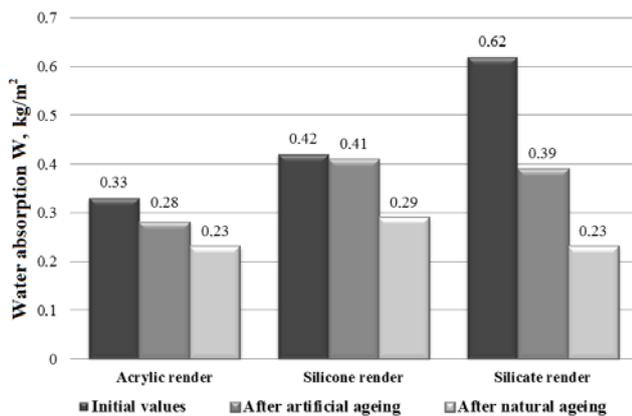
Fig. 5. Water absorption rates of ETICS samples before and after natural and artificial UV radiation ageing

The water absorption rate of ETICS samples was measured before and after exposure to UV radiation (Fig. 5).

The water absorption results after one year of laboratory cycling have shown that the absorption has decreased by half in silicate render samples (Fig. 5), furthermore, after one natural year it has decreased nearly three times. Likely, this happened due to the natural carbonation process during the testing procedures. The carbonation restricts the water absorption more in this case. The crystals formed after natural exposure (Fig. 4, f) were larger than after laboratory cycling (Fig. 4, i), therefore the open porosity of the render is more covered by crystals. Furthermore, during the carbonation process the surface become thicker and more durable [4]. This process takes place on all types of render. Likely, the solid film formed on the fresh acrylic and silicone render samples slowed down the carbonation process during the ageing procedures. However, the water absorption rates after one natural year of all types of renders become similar. It means that the binders and silicone-based water repellent additives influencing water absorption rate only at initial exploitation period (approximately one year). During this period the carbonation process takes place and protective crystal structure covers surfaces of all type of renders and defines the real water absorption rate of renders in exploitation conditions.
