Adhesive-bonded Repair for Cracked Metal Material of Remanufacture

By investigating Q235 steel containing center cracks commonly used in construction machinery, this study analyzed the stress intensity factors at the crack tip and the crack growth rate before and after the repair of the structure. The static mechanical properties and the stress-strain at different positions of the structure were studied before and after the repair. The principle of adhesively-bonded patch repair was also verified. The obtained results showed that the static mechanical properties of the damaged metal structure were significantly improved to 80 %. This was done through a single-sided repair using carbon/epoxy resin. A 90 % improvement was accomplished through double-sided repair.

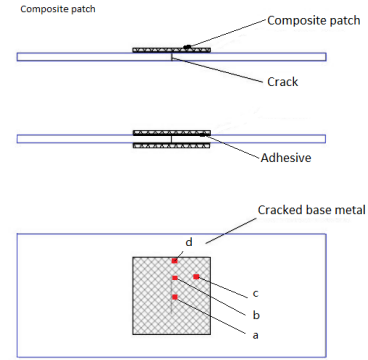
The cracked metal plate was repaired using composite patches based on an adhesively-bonded repair technique. The repaired structure was mainly composed of three parts, shown in Fig. 2. According to the sequence of the parts used in the repair technique, the first part referred to the cracked base metal. The adhesive layer and the composite patch, together, are the second and third parts. The repair model built in this study was repaired with single-sided and double-sided patches, separately. The corresponding stress intensity factors of the cracks were calculated using MATLAB software. The base metal applied was Q235 steel with the following size: 200 mm x 80 mm x 5 mm

(length $L1 \times$ width $B1 \times$ thickness $T1$). At the center of the plate, a crack was observed 24 mm in length. That is, $2a = 24$ mm, where a means the half length of the crack.

Fig. 2. Schematic diagram of gluing structure

We pasted a strain gauge (a) at the middle of the crack in the crack zones (a, b, c, d), as shown in Fig. 2. This location needed particular attention since the crack's existence made the micro strain extremely small, certainly smaller than the strain in the far-field region. Hence, the indication was that the load placed on this section was comparably small. We then pasted the strain gage (b), on the crack's tip, whose existence determined a relatively significant stress concentration in the area. Therefore, the region's micro strain was greater than the strain in the far-field region, revealing that in similar structures this section typically bears a heavier load. However, based on our experiments, we found that when we increased the stress to 160 MPa, the micro strain in the crack's tip (b) experienced an obvious reduction, indicating the occurrence of crack propagation. The strain gage (d)'s location was relatively far away from the crack site, and the micro strain presented a linear variation below 160 MPa. After the stress value exceeded 160 MPa, nearby micro strains also exhibited an obvious increase. Hence, we may conclude that crack propagation led to the crack's tip extending outward to the strain gage (b)'s surrounding area. This, in turn, resulted in further stress concentration in this area.

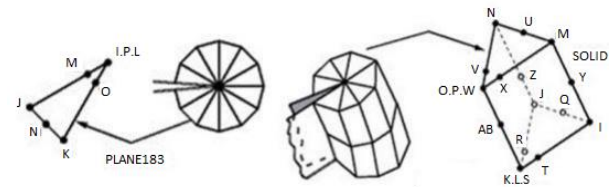
Fig. 3. Crack tip grid

Fig. 3 illustrates the grid at the crack tip where there is a great stress gradient. In Fig. 3, the letter has no actual meaning, but only the grid node. To capture such stress variation, the grids in the stress-induced deformed zone need to be refined.
