Non-Wear Effect on Composite Steel-Brass Surface

The paper deals with the investigation on friction couples sharing one composite surface. The composite friction surface consists of steel 45 and electropulse sprayed brass Л63 coating segments. The investigation objective is to determine the extent of the influence of the ratio of steel to brass coatings areas on the selective transfer effect in this friction surface. In the analysis of the friction surface state the characteristics of the formation of the brass servovite film have been evaluated while varying the areas of steel and brass segments in the friction surface. The latter and the resulting brass film have been analyzed by optical microscope. In the composite surface with no less than 50 % of brass coating segments area the non-wear effect can be achieved. Under 0.6 MPa pressure and 0.72 m/s sliding speed, in a friction couple the servovite film forms in 10...15 minutes. This film reduces the surface roughness from Ra 0.60 μm to Ra 0.10 μm .

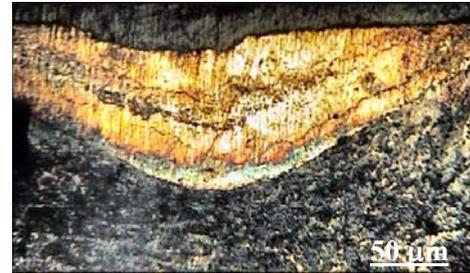
Fig. 2. Segment of brass coating on the friction surface (cross section)

After the electropulse coating spray the microscopic analysis of friction surfaces indicated the structure of coatings to be dense. Due to markedly high fluidity and speed of overheated brass particles the coating perfectly filled the surface of the pits formed on the surface area (Fig. 2).

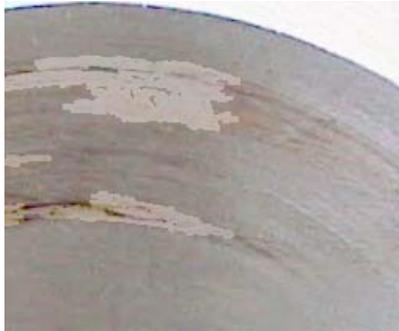
Fig. 4. Disk surface after the friction test with 50/50 block: light segments – copper coating (2:1)

50/50 blocks had been working the whole test period of 30 minutes without any vibration. After 18...20 min the temperature of the samples got settled at about 333 K . The first 10 min the changes in the lubricant state were being observed – microparticles of brass colour sprang up. The lubricant acquired yellowish brown colour. After 10...15 minutes a reddish discontinuous trace used to appear on the disk friction track (Fig. 4).
