Comparative Study for Corrosion Resistance of Ferrous and Non-ferrous Pipes Immersed in Magnetized Water

Bilal Ali Abbas AL-HALBOOSI, İsmail Hakkı KARA *

Metallurgy and Materials Engineering Department of Engineering Faculty, Karabük University, Karabük, 78050, Turkey

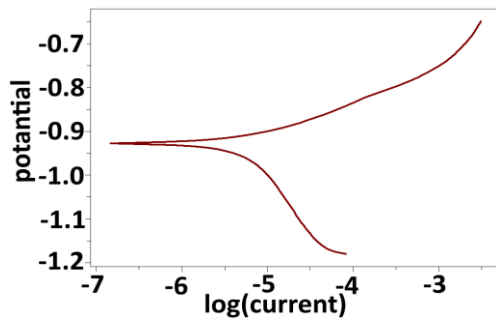
Fig. 4. Tafel curve of galvanized steel specimen in MWT applied water

Fig.4 and Fig.5 show Tafel curves obtained from potentiodynamic corrosion test results of galvanized steel and AZ31 Mg, respectively. It is measured that the corrosion rate of AZ31 is lower than galvanized steel. The corrosion rate of AZ31 was lower than the galvanized steel at 0.04421 mm/y and 0.07642 mm/y, respectively.

The more Ca and Mg content of AZ31 material enables the formation of calcite and MgO particles on the surface, where the passivation mechanism could be the reason for the better corrosion resistance for AZ31. Moreover, it is seen that the PE% (inhibition efficiency %) value of AZ31
