Energy Absorption and Damage Analysis of Glass Fibre Reinforced Polymer Spherical Core Sandwich Structures

The present study describes the energy absorption and damage analysis of the spherical core sandwich structures (SCSS) fabricated using woven Glass Fibre Reinforced Plastic (GFRP) by hand- layup method. Based on the core orientation, the spherical cores are categorized as stagger (S), regular (R), inverted (I), and interlock (L). The pitch distance and diameter of the models considered for the study are 24 mm and 16 mm, respectively. The specimens are subjected to a low velocity impact test (LVIT) at three different energy levels 9.9, 27.5, and 53.9 J respectively. Evaluations are carried out on the different kind of parameters namely coefficient of restitution (COR), energy absorption ratio, and energy loss percentage maximum displacement, maximum force, absorbed energy, and rebound energy. Among the models at every impact velocity it is found that the model R sustains a maximum force of 3078 N at 7 m/s impact velocity. The stagger model has recorded a maximum displacement of 34.4 mm among all velocities, whereas the regular model reveals a minimum displacement of 4.9 mm bas

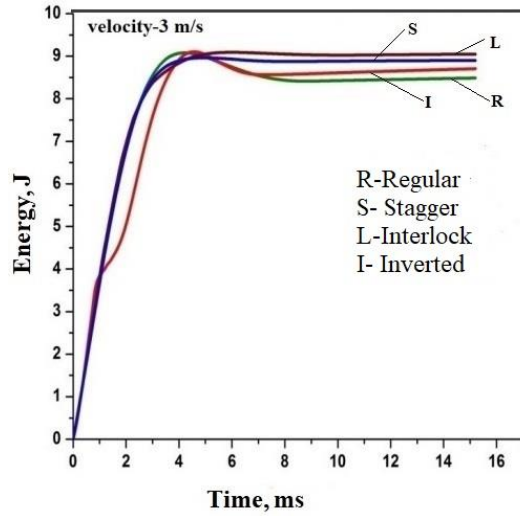
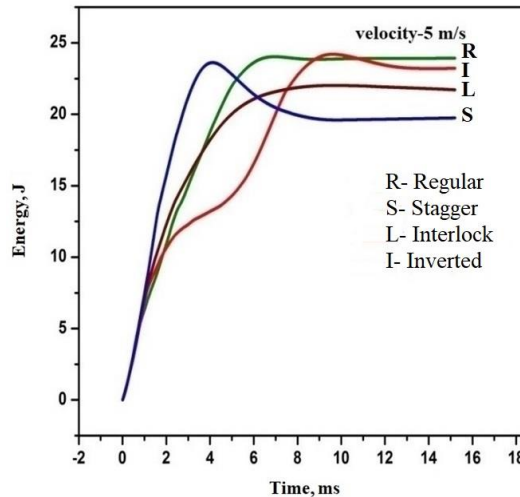
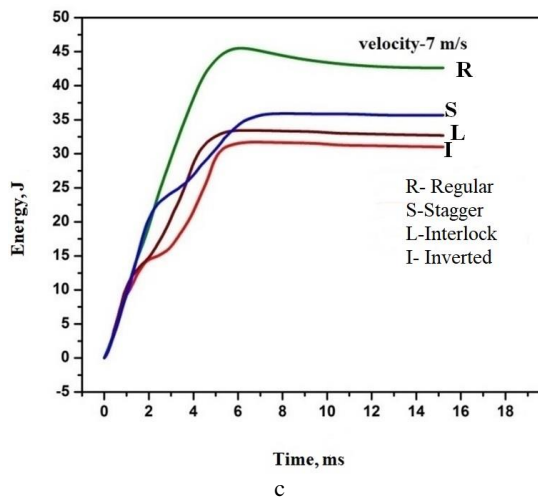
Fig. 3. Energy vs time for impact velocity of: a–3 m/s; b–5 m/s; c–7 m/s

From Fig. 3 among woven-GFRP models for 3 m/s, it is found that all the models except (I) show smooth curve patterns.

While in the model (I) initially the energy value curve reaches 4 J of energy at 1 milliseconds (ms) of time and

gets deflected and then reaches 9 J of energy at 4 ms of time, thus showing a deflected curve pattern. The model absorbs 8.6 J of energy, while the rebound energy is 0.7 J.

Whereas for the remaining models R, L and S the energy absorbed is 8.4, 8.8, and 8.5 J. Similarly the rebound energy of the models are as follows 0.8, 0.2, and 0.4 J. It has determined that the model L absorbs more energy with a value of 8.8 J with less rebound energy. Similar patterns are observed in 5 and 7 m/s impact velocities of SCSS. The concept of COR, ratio for energy absorption and ELP are discussed in detail [9].

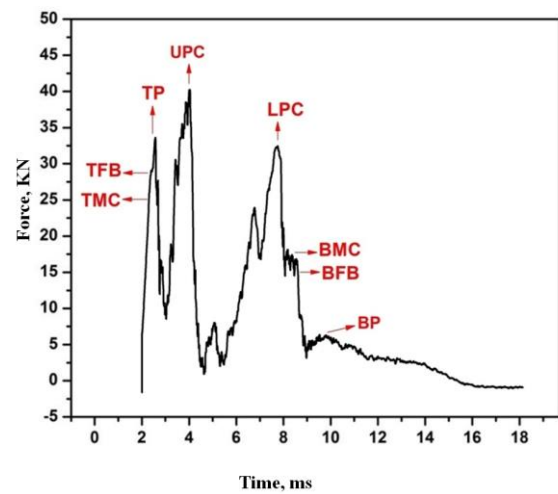
Fig. 4. Force vs time showing peaks corresponding damages

Fig. 4 shows the typical photograph of the force vs. time curve showing peaks corresponding to damages.

The damages observed in the SCSS are categorized as matrix cracking in the top face sheet (TMC), Top fibre breakage (TFB) and perforation in the top face sheet (TP).

Similar failures are noticed in the bottom facing sheet and are categorized as matrix cracking in the bottom facing sheet (BMC), Bottom fibre breakage (BFB) and perforation in the bottom facing sheet (BP). The damages observed in the core region are upper and lower portion of the core crushing namely (UPC and LPC). The crack propagation progress and the defects in the model could be assessed and cross-verified by visual inspection as well as ultrasound testing. The damage area is further characterized as Top damage area (TDA), Top fracture area (TFA), Bottom damage area (BDA), and Bottom fracture area (BFA).

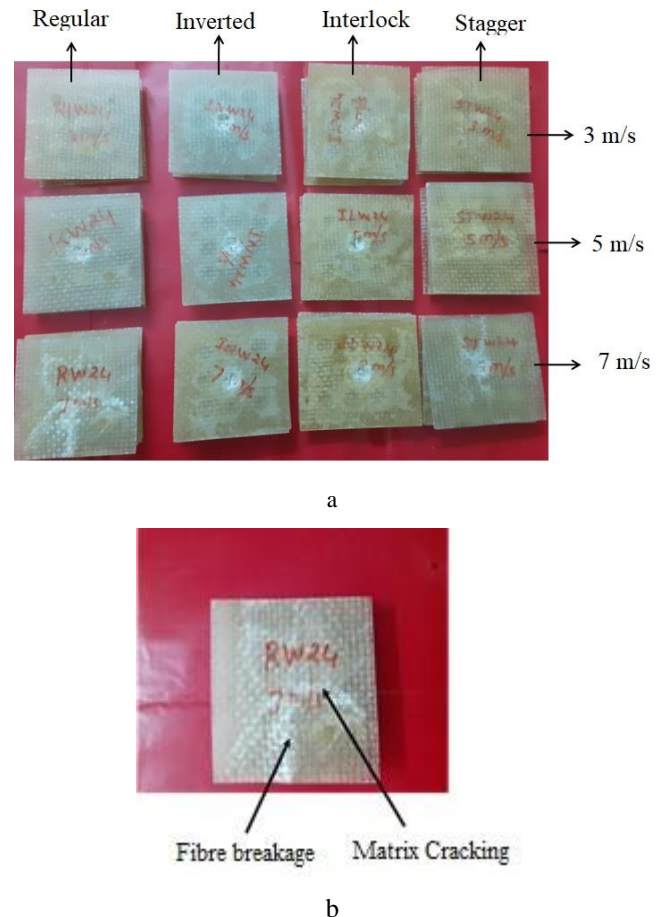
Fig. 5. a–top damage portion of the SCSS; b–typical photograph of the top side of R at 7 m/s impact velocity

The face sheet failure at the top is noticed to exhibit various patterns of failures in all the models at various velocities as shown in Fig. 5. A dent or depression associated with the matrix cracking is observed in every model at 3 m/s velocity. Whereas at 5 m/s the matrix

cracking observed in the models is circular and in addition to it splits or cracks originate from the damaged area due to fibre breakage. At 7 m/s the damages seen in the specimens R and S are irregular in shape with a lot of branched cracks. Whereas for the remaining models the damaged area is circular in shape with the combination of fibre breakage. In addition to it in the model R and S the face sheet is fully debonded from the core. Similar type of damage patterns are noticed in the honeycomb sandwich constructions (Antony Arul Prakash et. al. 2014) [2].

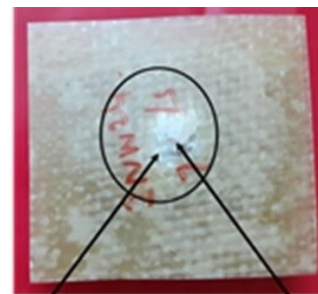
Fig. 7. a–bottom damage portion of the SCSS; b–typical photograph of the bottom side of I at 7 m/s impact velocity

The failure noticed in the bottom face sheet of the specimens for all velocities is shown in Fig. 7. At 3 m/s the specimen doesn't exhibit any damage.

While at 5 m/s velocity the matrix cracking observed in the models is circular in shape with the combination of cracks. At 7 m/s velocity, majority of the model exhibits a combination of fibre breakage and cracks along with circular shape damage. In addition to it in model I the detachment of the bottom face sheet and core is noticed.

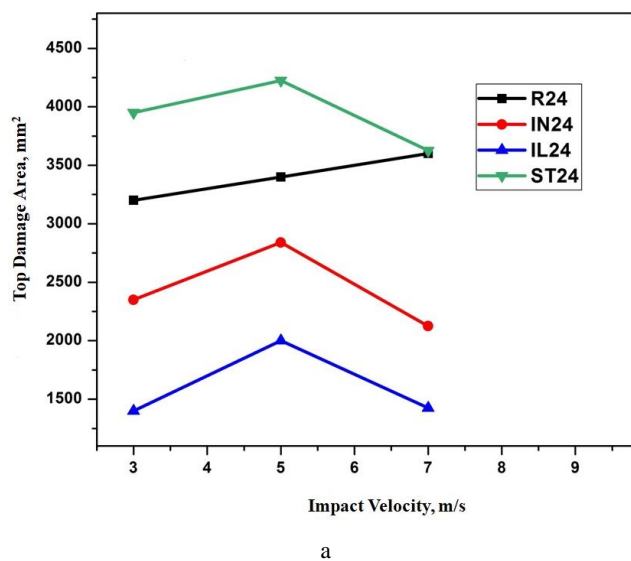
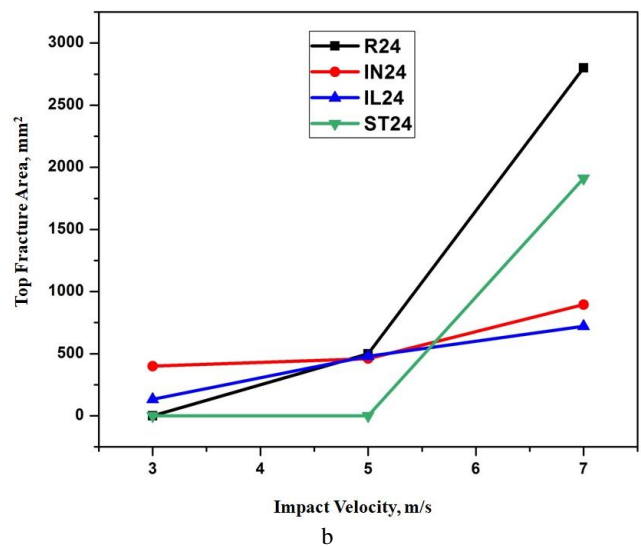
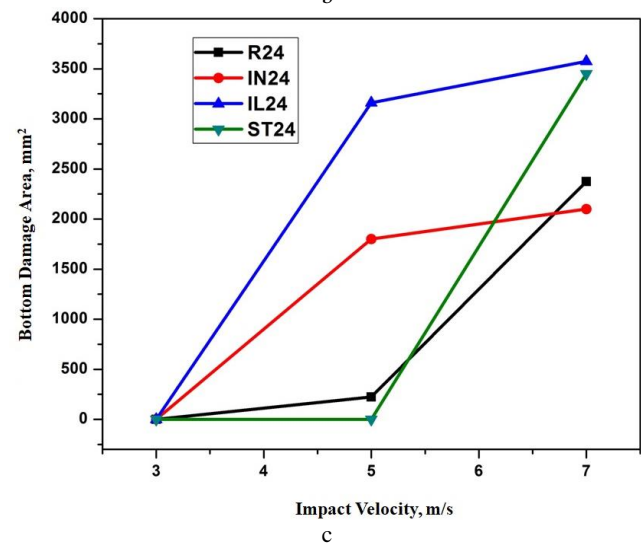
Fig. 8. Damage area: a-top; b-bottom; Fracture area: c-top; d-bottom fracture area

A detailed assessment of the extent of damage of the SCSS was carried out using visual inspection and ultrasound inspection. The damaged areas have been categorised as Top damage area (TDA), Top fracture area (TFA), Bottom damage area (BDA) and Bottom fracture area (BFA). Wherein, damage area (DA) refers to the area where matrix cracking alone has occurred and fracture area refers to the area wherein fibre breakage has also occurred. In addition to it, the penetration depth is estimated by a dial gauge. From Table 2 among woven-GFRP spherical models at 3 m/s velocity, it is found that the damage area is maximum for S whose value is 3950 mm², which indicates that 35.0 % of the specimen had been damaged. Whereas the specimen L has a minimum value of 1400 mm² (12.7 %). While comparing among 5 m/s it is found that model S shows maximum damage area of 4225 mm², which indicates 38.4 % of the damage.

Whereas the model L shows the minimum damage area of 2000 mm² (18.18 %). Among 7 m/s velocity the specimen S shows a maximum damage area of 3625 mm²

which implies the contribution of 32.9 % of the damage, whereas the model L shows the minimum damage area of 1425 mm² (12.9 %).

From Table 2 among woven-GFRP spherical models at 3 m/s it is found that fracture area is maximum for I with a value of 400 mm² (3.63 %), whereas model S shows no fracture area. While comparing among 5 m/s velocity it is noticed that the specimen R shows the maximum fracture area of 500 mm² (4.5 %), whereas model S shows the minimum fracture area of 250 mm² (2.27 %). Among 7 m/s specimen R shows the maximum fracture area of 2800 mm² (25.45 %), whereas model L shows the minimum fracture area of 721 mm² (6.55 %).

From Table 2 among woven-GFRP spherical specimens at 3 m/s it is noticed that there is no damaged area on the bottom side. While comparing among 5 m/s it is found that model L shows the maximum bottom damage area of 3160 mm² (28.7 % of damages), whereas the model S shows no bottom damage area. Among 7 m/s specimen L shows the maximum bottom damage area of 3575 mm² (32.5 %), whereas the model I shows the minimum bottom damage area of 2100 mm² (19.09 %). From Table 2 at 3 m/s velocity, it is noticed that there is no bottom fracture area in the models. While comparing among 5 m/s it is seen that model L shows the maximum bottom fracture area of 440 mm² (4 %), whereas the remaining models

show no bottom fracture area. Among 7 m/s specimen R shows the maximum bottom fracture area of 1224 mm² (11.12 %), whereas model S shows the minimum bottom damage area of 655 mm² (5.9 %). As the impactor hits the specimen the top facing sheet absorbs more amount of energy when compared to the bottom facing sheet. While the impactor starts to descend the energy is dissipated, which results in the minimum absorption by the bottom facing sheet [9]. So the maximum damages are noticed in the top facing sheet than the bottom. But while comparing fracture area it is noted that fibre breakage occurs near the area where the impactor penetrates the specimen. This is the reason for the value of fracture area to differ minimum among top and bottom facing sheets while comparing among damage area. Similarly from Table 2 at 3 m/s velocity, it is found that penetration depth is maximum for the model L with a value of 8 mm, whereas the models R and S show no penetration. While comparing among 5 m/s it is noted that the depth is maximum for the model L and I with a value of 14 mm, while model R shows an 8 mm depth of penetration. Among 7 m/s velocity model I show the maximum depth of penetration with a value of 20 mm. Fig. 8 shows the graphs of the top damage area, bottom damage area, top fracture area, and bottom fracture area of spherical core sandwich structures.

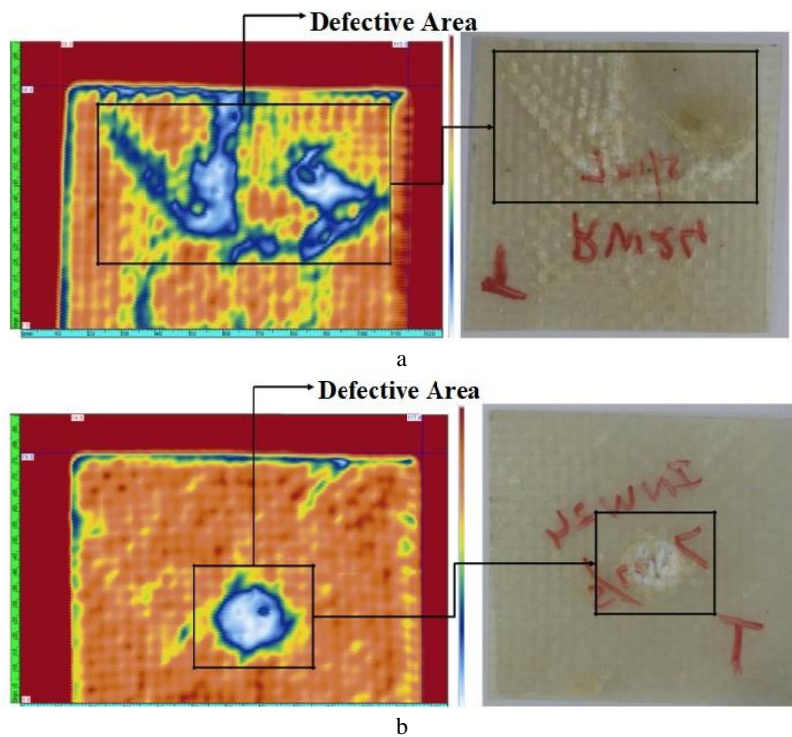
Fig. 9. Typical photographs of the ultrasound images of the models: a – regular; b – inverted

The tested specimens are subjected to ultra sound testing in order to assess the damage area both at the top and bottom surface of sandwich constructions. Fig. 9 shows the typical photographs of the ultrasound c- scan images of the top surface of the regular model and inverted model. The vertical colour bar ranges from white to red which is measured as 0 to 100. The transmitted signal from the probe is received at the receiver end without any scattered then that particular region is represented in red colour which indicates that there is no damage.

If the area is indicated by white colour then it indicates all the signals are lost and there is perforation in that particular area [9]. The remaining colour bar indicates the matrix cracking and fibre breakages as per the signals received at the receiver end.
