Energy Absorption and Damage Analysis of Glass Fibre Reinforced Polymer Spherical Core Sandwich Structures

The present study describes the energy absorption and damage analysis of the spherical core sandwich structures (SCSS) fabricated using woven Glass Fibre Reinforced Plastic (GFRP) by hand- layup method. Based on the core orientation, the spherical cores are categorized as stagger (S), regular (R), inverted (I), and interlock (L). The pitch distance and diameter of the models considered for the study are 24 mm and 16 mm, respectively. The specimens are subjected to a low velocity impact test (LVIT) at three different energy levels 9.9, 27.5, and 53.9 J respectively. Evaluations are carried out on the different kind of parameters namely coefficient of restitution (COR), energy absorption ratio, and energy loss percentage maximum displacement, maximum force, absorbed energy, and rebound energy. Among the models at every impact velocity it is found that the model R sustains a maximum force of 3078 N at 7 m/s impact velocity. The stagger model has recorded a maximum displacement of 34.4 mm among all velocities, whereas the regular model reveals a minimum displacement of 4.9 mm bas

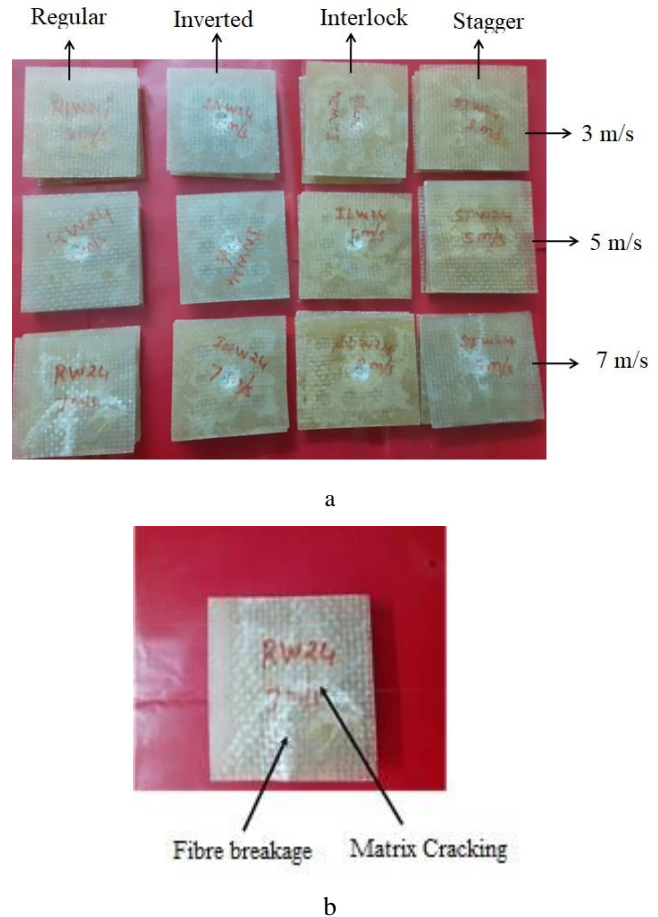
Fig. 5. a–top damage portion of the SCSS; b–typical photograph of the top side of R at 7 m/s impact velocity

The face sheet failure at the top is noticed to exhibit various patterns of failures in all the models at various velocities as shown in Fig. 5. A dent or depression associated with the matrix cracking is observed in every model at 3 m/s velocity. Whereas at 5 m/s the matrix

cracking observed in the models is circular and in addition to it splits or cracks originate from the damaged area due to fibre breakage. At 7 m/s the damages seen in the specimens R and S are irregular in shape with a lot of branched cracks. Whereas for the remaining models the damaged area is circular in shape with the combination of fibre breakage. In addition to it in the model R and S the face sheet is fully debonded from the core. Similar type of damage patterns are noticed in the honeycomb sandwich constructions (Antony Arul Prakash et. al. 2014) [2].

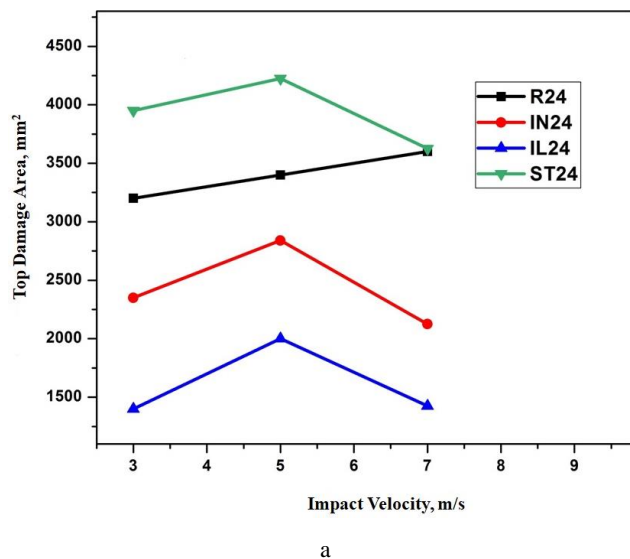
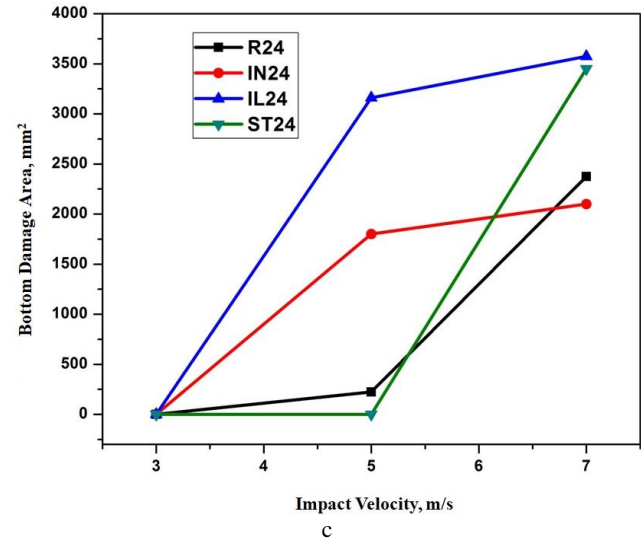
Fig. 8. Damage area: a – top; b – bottom; Fracture area: c – top; d – bottom fracture area

A detailed assessment of the extent of damage of the SCSS was carried out using visual inspection and ultrasound inspection. The damaged areas have been categorised as Top damage area (TDA), Top fracture area (TFA), Bottom damage area (BDA) and Bottom fracture area (BFA). Wherein, damage area (DA) refers to the area where matrix cracking alone has occurred and fracture area refers to the area wherein fibre breakage has also occurred. In addition to it, the penetration depth is estimated by a dial gauge. From Table 2 among woven-GFRP spherical models at 3 m/s velocity, it is found that the damage area is maximum for S whose value is 3950 mm², which indicates that 35.0 % of the specimen had been damaged. Whereas the specimen L has a minimum value of 1400 mm² (12.7 %). While comparing among 5 m/s it is found that model S shows maximum damage area of 4225 mm², which indicates 38.4 % of the damage.

Whereas the model L shows the minimum damage area of 2000 mm² (18.18 %). Among 7 m/s velocity the specimen S shows a maximum damage area of 3625 mm²

which implies the contribution of 32.9 % of the damage, whereas the model L shows the minimum damage area of 1425 mm² (12.9 %).

From Table 2 among woven-GFRP spherical models at 3 m/s it is found that fracture area is maximum for I with a value of 400 mm² (3.63 %), whereas model S shows no fracture area. While comparing among 5 m/s velocity it is noticed that the specimen R shows the maximum fracture area of 500 mm² (4.5 %), whereas model S shows the minimum fracture area of 250 mm² (2.27 %). Among 7 m/s specimen R shows the maximum fracture area of 2800 mm² (25.45 %), whereas model L shows the minimum fracture area of 721 mm² (6.55 %).

From Table 2 among woven-GFRP spherical specimens at 3 m/s it is noticed that there is no damaged area on the bottom side. While comparing among 5 m/s it is found that model L shows the maximum bottom damage area of 3160 mm² (28.7 % of damages), whereas the model S shows no bottom damage area. Among 7 m/s specimen L shows the maximum bottom damage area of 3575 mm² (32.5 %), whereas the model I shows the minimum bottom damage area of 2100 mm² (19.09 %). From Table 2 at 3 m/s velocity, it is noticed that there is no bottom fracture area in the models. While comparing among 5 m/s it is seen that model L shows the maximum bottom fracture area of 440 mm² (4 %), whereas the remaining models

show no bottom fracture area. Among 7 m/s specimen R shows the maximum bottom fracture area of 1224 mm² (11.12 %), whereas model S shows the minimum bottom damage area of 655 mm² (5.9 %). As the impactor hits the specimen the top facing sheet absorbs more amount of energy when compared to the bottom facing sheet. While the impactor starts to descend the energy is dissipated, which results in the minimum absorption by the bottom facing sheet [9]. So the maximum damages are noticed in the top facing sheet than the bottom. But while comparing fracture area it is noted that fibre breakage occurs near the area where the impactor penetrates the specimen. This is the reason for the value of fracture area to differ minimum among top and bottom facing sheets while comparing among damage area. Similarly from Table 2 at 3 m/s velocity, it is found that penetration depth is maximum for the model L with a value of 8 mm, whereas the models R and S show no penetration. While comparing among 5 m/s it is noted that the depth is maximum for the model L and I with a value of 14 mm, while model R shows an 8 mm depth of penetration. Among 7 m/s velocity model I show the maximum depth of penetration with a value of 20 mm. Fig. 8 shows the graphs of the top damage area, bottom damage area, top fracture area, and bottom fracture area of spherical core sandwich structures.

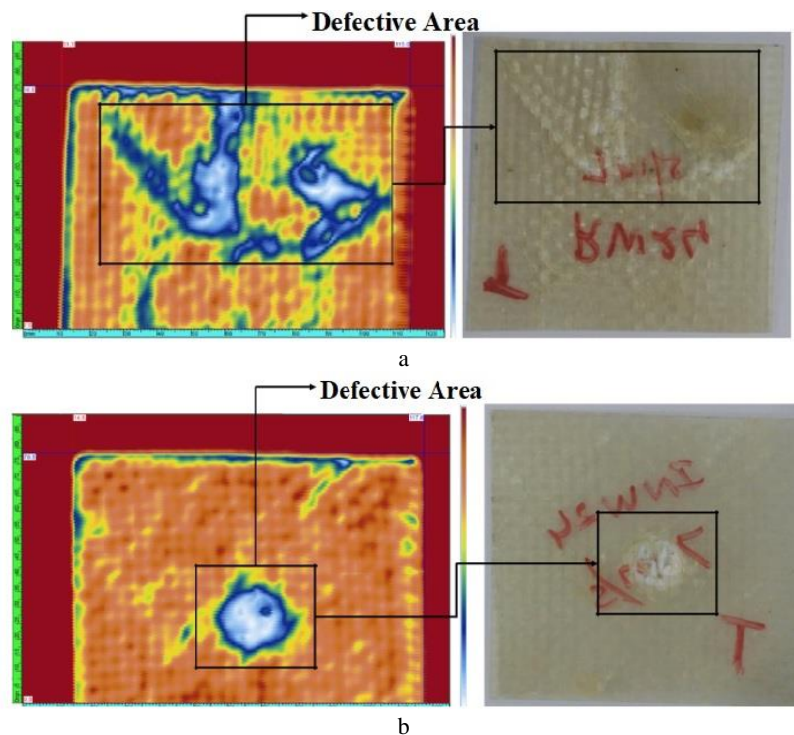
Fig. 9. Typical photographs of the ultrasound images of the models: a – regular; b – inverted

The tested specimens are subjected to ultra sound testing in order to assess the damage area both at the top and bottom surface of sandwich constructions. Fig. 9 shows the typical photographs of the ultrasound c- scan images of the top surface of the regular model and inverted model. The vertical colour bar ranges from white to red which is measured as 0 to 100. The transmitted signal from the probe is received at the receiver end without any scattered then that particular region is represented in red colour which indicates that there is no damage.

If the area is indicated by white colour then it indicates all the signals are lost and there is perforation in that particular area [9]. The remaining colour bar indicates the matrix cracking and fibre breakages as per the signals received at the receiver end.
