Stress-induced Hydride Reorientation and Cracking in Fuel Cladding Tube

Albertas GRYBĖNAS, Vidas MAKAREVIČIUS*, Tadas KALIATKA,
Gintautas DUNDULIS, Rita KRIŪKIENĖ

Lithuanian Energy Institute, Breslaujos 3, LT-3035 Kaunas, Lithuania

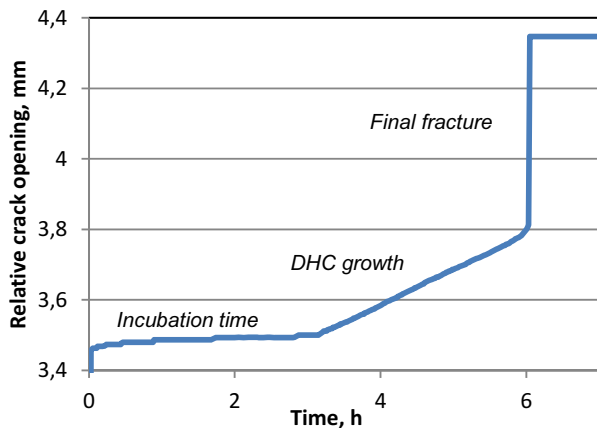
Fig. 8. Testing of Zry-4 CW cladding at 250 °C: relative crack opening vs. time curve

As it is shown in Table 2, $K_{I_{max}} \leq K_{IH}$ that is $K_{I_{max}}$ values could be too low to initiate DHC. Therefore for the test of specimen No 5.1.5 the load was increased to $K_{I_{max}} = 6.2 \text{ MPa}\cdot\text{m}^{1/2}$. It was supposed that without fatigue crack DHC would not start or testing time will be long. Therefore test was performed at a constant temperature 250 °C after cooling from 340 °C. Nevertheless, as it is shown in Fig. 8 after 3 h of incubation time DHC growth started and in the next 3 h failure of the cladding occurred. The DHC growth is clearly visible at the fracture surface (Fig. 9).
