# Surface Corrosion Detection for Ferrous-metal Parts: Application of Artificial Intelligence, Python and Microscopic Images

# Roman WDOWIK<sup>1\*</sup>, Artur BEŁZO<sup>1</sup>, Regita BENDIKIENE<sup>2</sup>

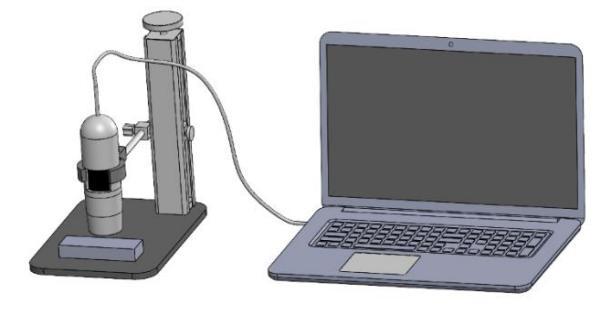
Fig. 1. Image recording test stand configuration: USB microscope and PC-software set

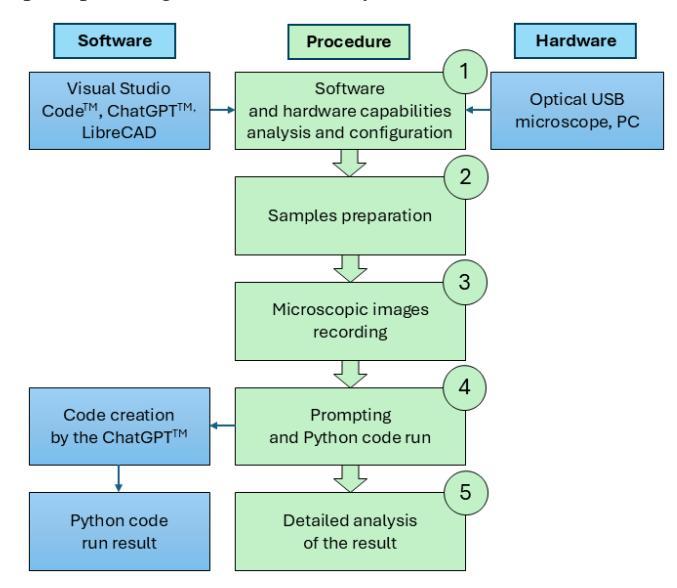
Fig. 2. Experimental procedure

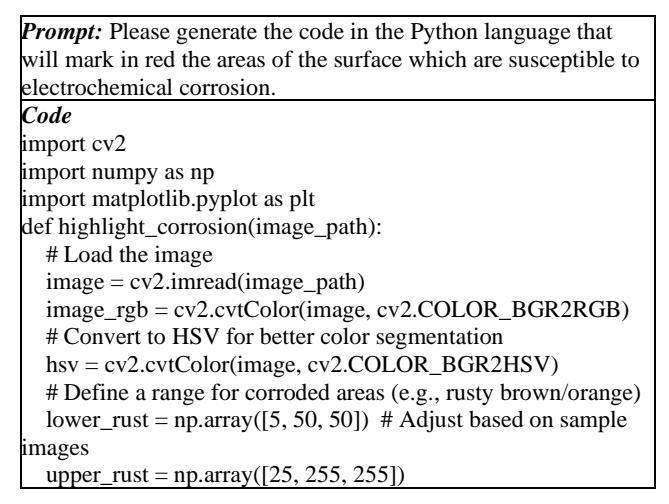
# Create a mask to detect rusty areas mask = cv2.inRange(hsv, lower rust, upper rust) # Apply morphological operations to refine the mask kernel = np.ones((3, 3), np.uint8)mask = cv2.morphologyEx(mask, cv2.MORPH\_CLOSE, ernel, iterations=2) # Find contours of the detected corroded areas contours, \_ = cv2.findContours(mask, v2.RETR\_EXTERNAL, cv2.CHAIN\_APPROX\_SIMPLE) # Draw the contours on the original image in red result = image\_rgb.copy() cv2.drawContours(result, contours, -1, (255, 0, 0), 2) # Red color marking # Display the original and processed images fig, ax = plt.subplots(1, 2, figsize=(12, 6))ax[0].imshow(image\_rgb) ax[0].set\_title("Original Image") ax[0].axis("off") ax[1].imshow(result) ax[1].set\_title("Highlighted Corrosion Areas") ax[1].axis("off") plt.show() # Example usage image\_path = "corroded\_surface.jpg" # Replace with your image path

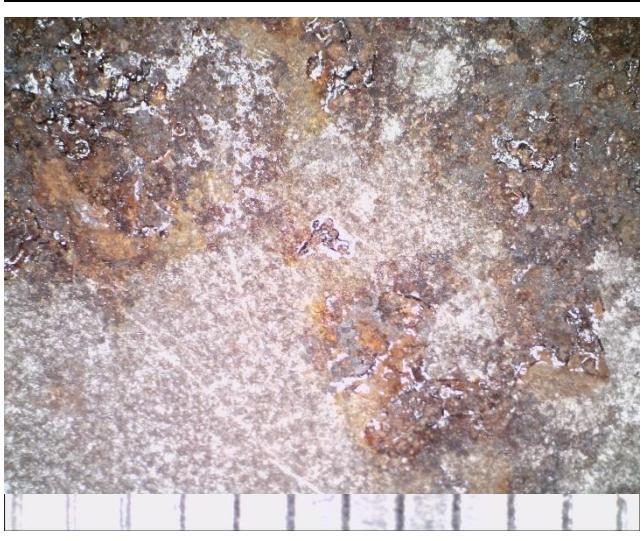
**Fig. 3.** Original image of the first corroded surface (distance between vertical lines is ~1 mm)

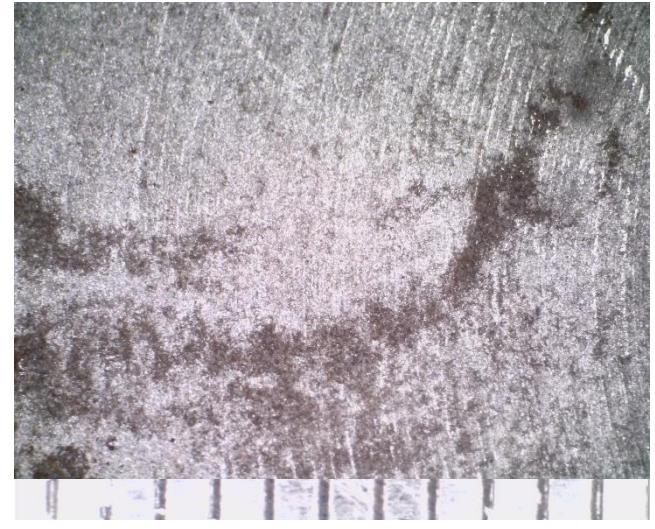
**Fig. 4.** Original image of the second corroded surface (distance between vertical lines is ~1 mm)

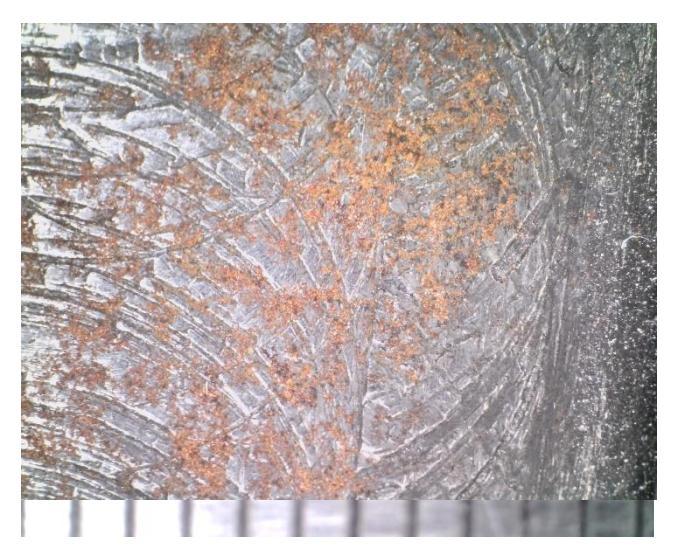
**Fig. 5.** Original image of the third corroded surface (distance between vertical lines is ~1 mm)

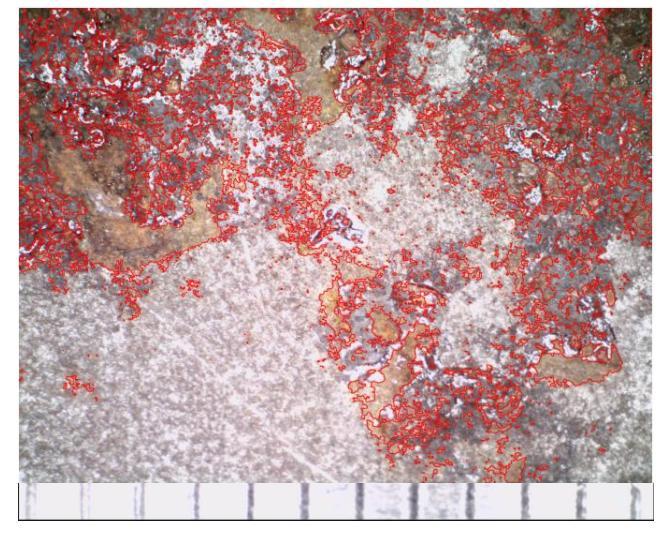
Fig. 6. Outlined corroded areas of the first corroded surface (distance between vertical lines is ~1 mm)

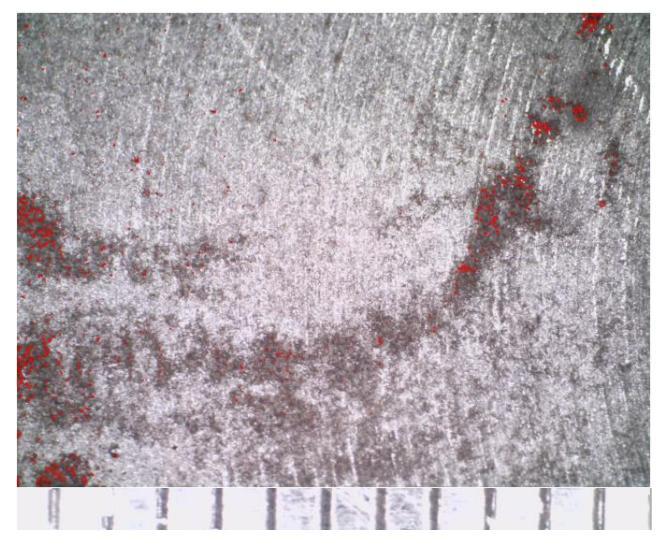
**Fig. 7.** Outlined corroded areas of the second corroded surface surface (distance between vertical lines is ~1 mm)

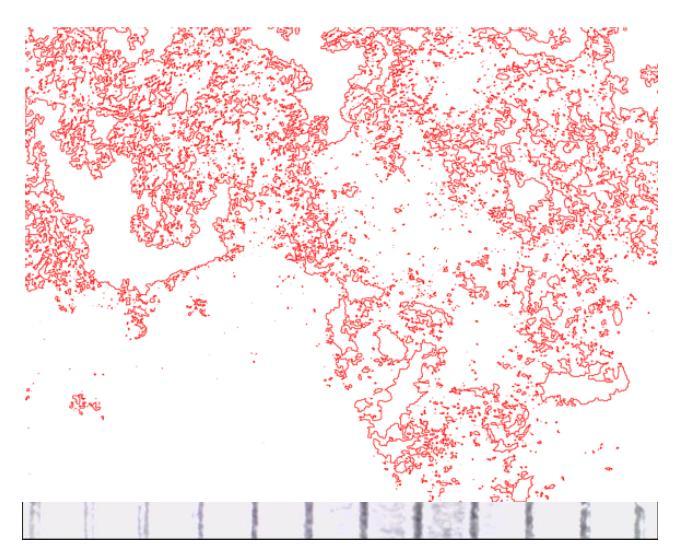
**Fig. 8.** Outlines of the corroded surface presented in Fig. 3 (distance between vertical lines is ~1 mm)

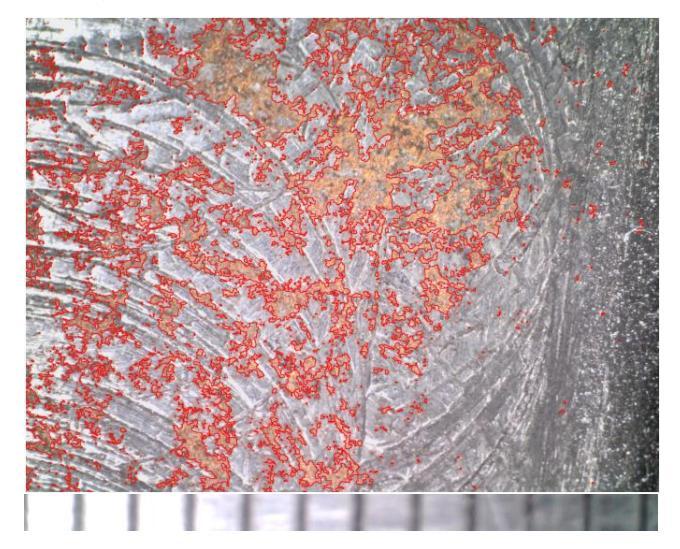
**Fig. 9.** Outlined corroded areas of the third corroded surface (distance between vertical lines is ~1 mm)

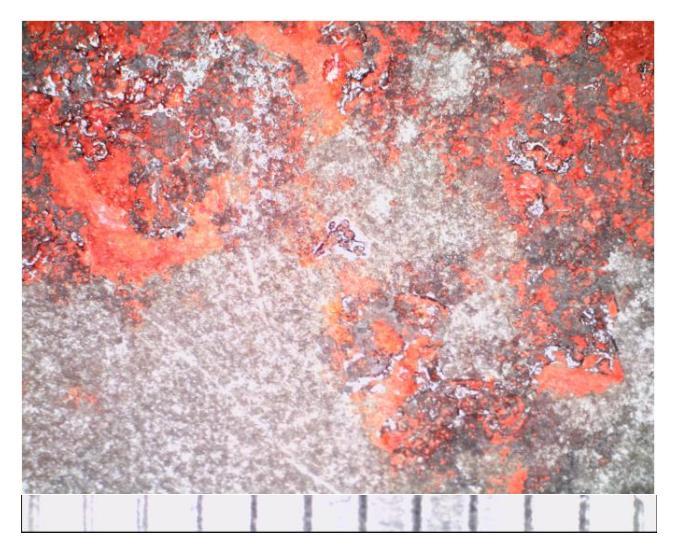
Fig. 10. Hatched corroded areas of the first corroded surface (distance between vertical lines is ~1 mm)

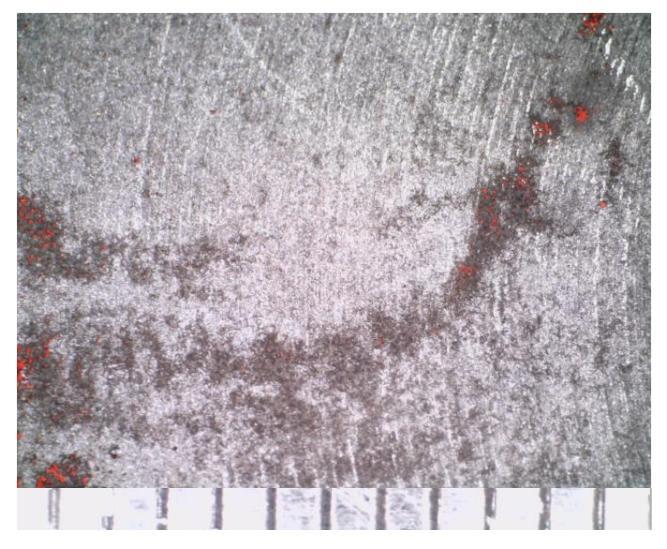
Fig. 11. Hatched corroded areas of the second corroded surface (distance between vertical lines is ~1 mm)

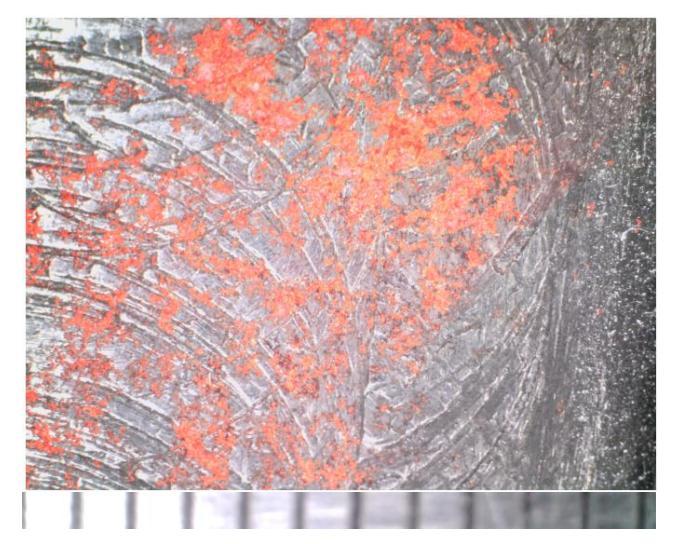
Fig. 12. Hatched corroded areas of the third corroded surface (distance between vertical lines is ~1 mm)

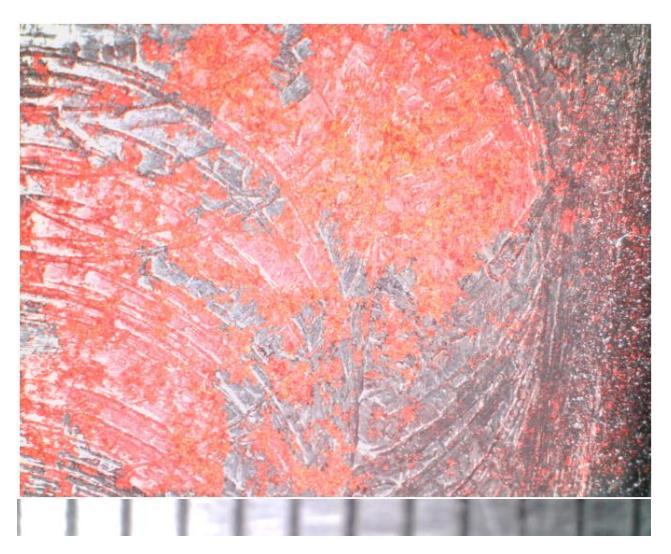
**Fig. 13.** Hatched corroded areas of the third corroded surface (distance between vertical lines is ~1 mm) – changed hatching parameters in the Python code

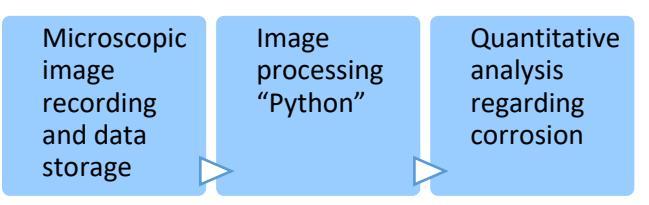
Fig. 14. Basic steps regarding quantitative analysis

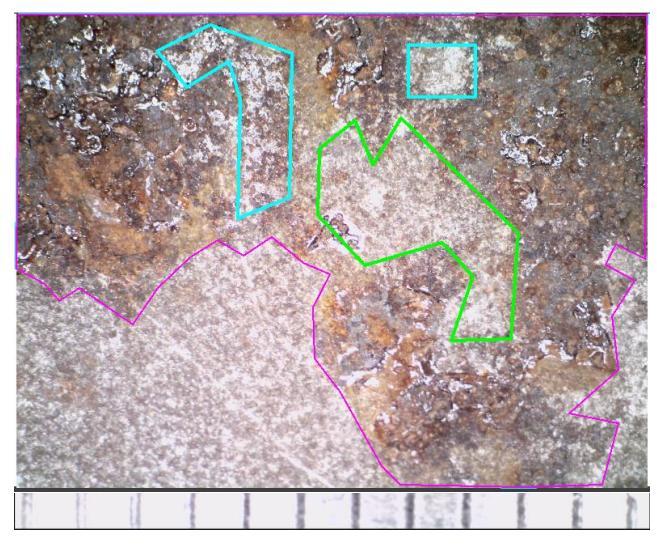
Fig. 15. Approximate calculation of the area by the use of the LibreCAD software tool for area measurement

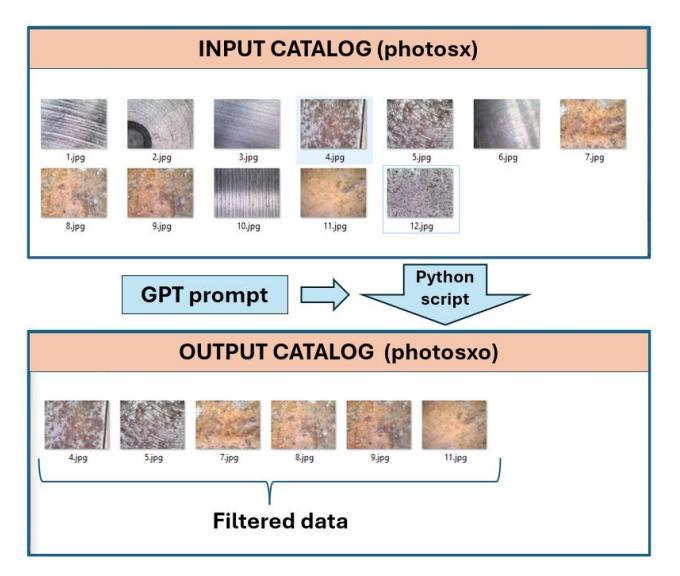
Fig. 16. Automated classification of corroded surfaces
