Wear Behavior and Microstructure of Thermally Sprayed NiCrBSiFeC and Composite NiCrBSiFeC-WC(Co) Coatings

In this work, a study was carried out on the friction and wear behavior of flame thermal sprayed NiCrBSiFeC-WC(Co) composite and NiCrBSiFeC coatings subjected to severe wear conditions. For this purpose, flame remelted samples were tested in reciprocating wear conditions based on a cylinder-on-flat configuration. The wear assessment of the coatings was achieved using scanning electron microscopy (SEM) and 3D optical profilometry. The microstructure and the mechanical properties of the coatings were investigated using SEM, EDS and XRD techniques as along with indentation tests. The tribological behavior of the substrate and the coatings was successfully studied thanks to wear tests conducted on an adapted multi test apparatus. The results show that both NiCrBSiFeC and composite coatings induced a significant increase in the steel substrate hardness and wear resistance due to the formation of precipitates with high hardness well dispersed within an ultra-crystalline structure. Besides, adding WC(Co) to NiCrBSiFeC leads to a composite coating with hardness and wear resistance fur

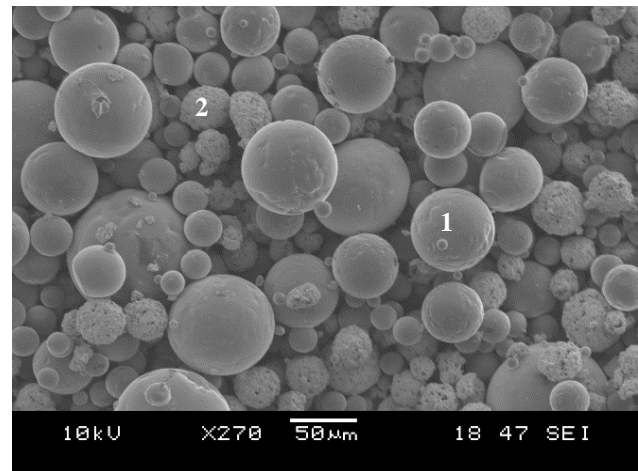
Fig. 1. SEM morphology of a mixture of the as-received powders M30C: M (1), C (2)

manufactured by Oerlikon Metco Company, its brand is Woka 3203. The size of the powder particles is principally in the range of 20 to 125 μm for the NiCrBSiFeC alloy and 20 to 53 μm for the WC(Co) powder. As the SEM micrograph (Fig. 1) shows, the particles for both powders are essentially spherically in shape.

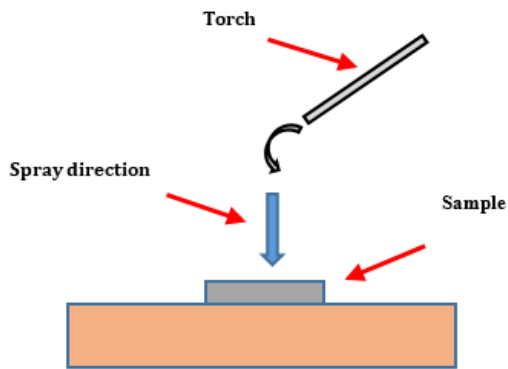
Fig. 2. Flame thermal spraying process

The deposition of the coatings was achieved using flame thermal spray process (Fig. 2) according to the technological parameters given in Table 2. To guarantee adequate adhesion of the coatings to the substrate, a preheating of the substrate was carried out before spraying with the same spray torch (without powder). Prior to composite coatings deposition, a thin bonding interlayer of the metallic powder (NiCrBSiFeC) was applied using the same process. A non-contact infrared pyrometer was used to control the temperature of the substrate during preheating. The spraying was performed after reaching the desired temperature (200 °C–250 °C). The coatings were formed through sweeping the surface of a fixed substrate by the flame of the torch. A six-pass deposition was applied to obtain the required thickness (480 μm –550 μm).

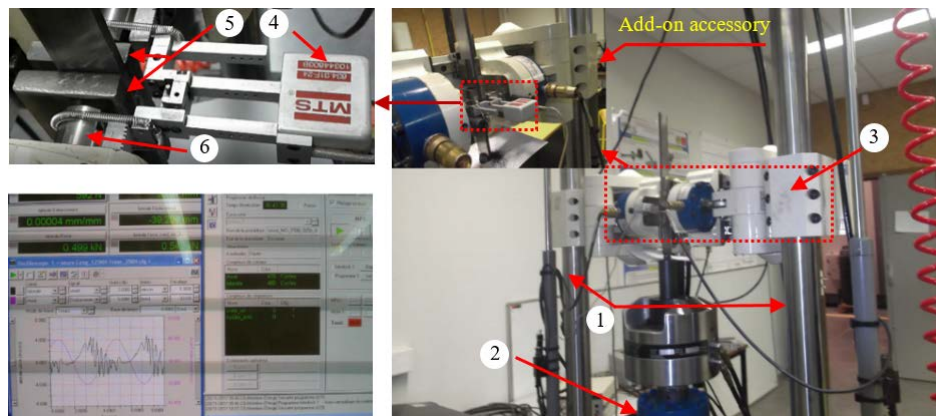
Fig. 3. Wear test machine including the add-on accessory and the monitoring software

execution. The adapted equipment is a device that allows a conventional fatigue machine to be adapted as a tribometer to perform sliding of a reciprocating specimen under a stationary pin. This device adds a second axis to a usual fatigue machine in the form of an add-on accessory. The apparatus can also be used as a fretting-wear machine or a fretting-fatigue machine. This device is supported by a crosspiece (3: white), which is attached to the two columns (1) of a standard fatigue machine. Several pin shapes may be used with this device. The pins are fixed in the supports (6) and allow the specimen (5) to be pressed with a perfect symmetry in the form of a pinching motion. In the tribological configuration of the device, the specimen (5) is driven by the fatigue machine actuator in a vertical alternative movement. The friction force is measured using two load cells incorporated in the fatigue machine (2). The coefficient of friction (COF) is recorded in situ by means of acquisition software (Fig. 3) and the average COF is evaluated in the steady state zone. The wear depth corresponds to half of the measurement given by the extensometer (4). Details of the apparatus are reported elsewhere [11].

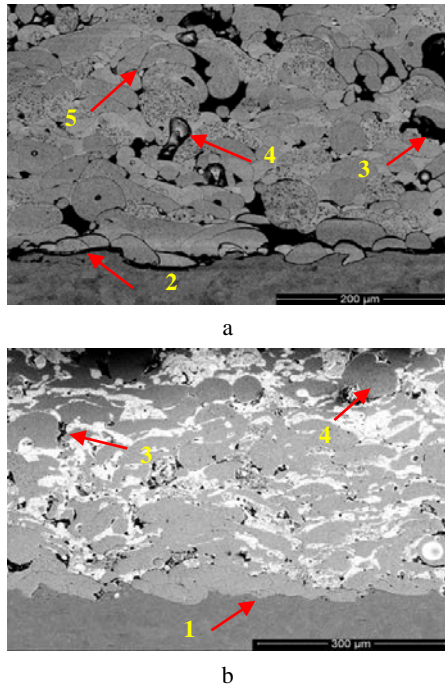
Fig. 4. SEM Comparative microstructure of as-sprayed coatings: a–NiCrBSiFeC; b–NiCrBSiFeC-WC(Co), the arrows indicate: 1–substrate-coating interface; 2–oxides; 3–pore; 4–unmolten particle; 5–splat boundary.

From the micrographs presented in Fig. 4 and Fig. 9, the layers of the as-sprayed coatings show a general lamellar structure with a few pores, oxides, and unmelted particles.

Individual splats are well recognized, and small sized scattered precipitates can be clearly seen in almost all splats of the NiCrBSiFeC and the composite coatings. This has also been discerned in previous works [3–5, 13, 16]. The coating-substrate interface and splats boundaries are very clear and the substrate roughness profile stemming from surface preparation was preserved. This gives evidence that the coating bonding to the substrate and between splats are both essentially mechanical. In addition, single metallic (grey region) and cermet (white region) splats can clearly be observed in the composite coating. Moreover, the latter present less porosity and more flattened splats than the NiCrBSiFeC coating. The low porosity is thought to be due to the small size WC(Co) particles that can be easily inserted into voids between the metallic particles thereby increasing the density.

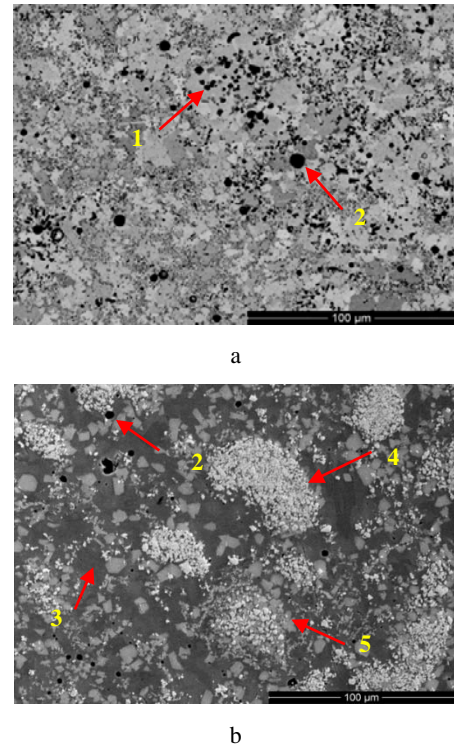
Fig. 5. SEM Comparative microstructure of the remelted coatings: a–NiCrBSiFeC; b–NiCrBSiFeC-WC(Co). The arrows indicate: 1–blocky precipitates; 2–rounded pore; 3–matrix; 4–unmolten WC carbides; 5 molten WC carbides

As illustrated in Fig. 5–Fig. 7 and Table 3, the splats boundaries are completely eliminated and the surface roughness has intensely decreased for the two coatings NiCrBSiFeC and NiCrBSiFeC-WC(Co) after remelting compared to the as-sprayed coatings.

The two coatings exhibit practically almost pore-free, nanoscale grained and homogenized microstructure characterized by coarser well-dispersed precipitates, as well as small isolated rounded pores. This is in agreement with previous studies [9, 12–16]. In addition, the composite coating shows molten (white) and unmolten (light grey) WC carbide particles well dispersed in the matrix.

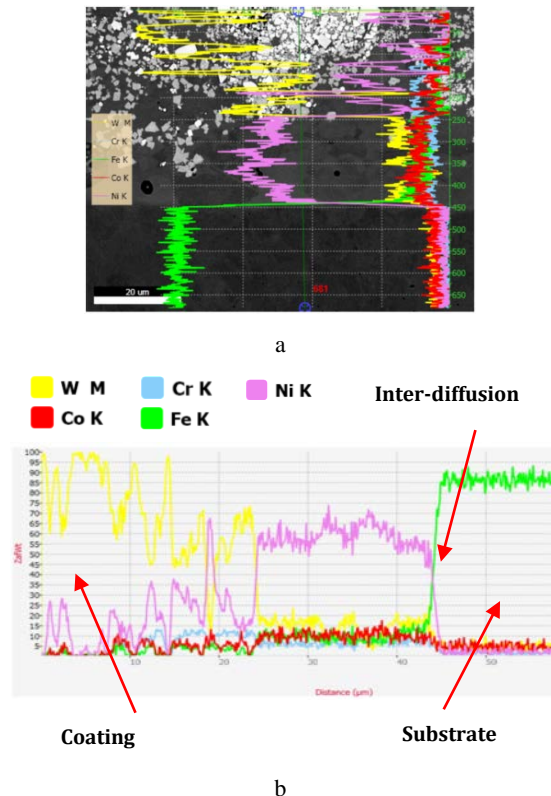
Fig. 6. SEM-EDS line scan profiles at the substrate-coating interface (green line) of the remelted NiCrBSiFeC-WC(Co) coating

It can obviously be noticed from Fig. 6 a that the boundary between the coatings and the substrate has totally disappeared, evidence of good adhesion.

SEM scan line analysis (Fig. 6 b) revealed the existence of a transition layer between the substrate and the remelted coatings. This is seemingly due to inter-diffusion phenomena occurring between the coating at its liquid state after remelting at high temperature and the substrate. The transition layer mainly contains Ni and Fe elements and is about 2.4 μm thick, evidence that the metallurgical bond has been successfully established. This is in line with previous studies [5–8, 16–18].

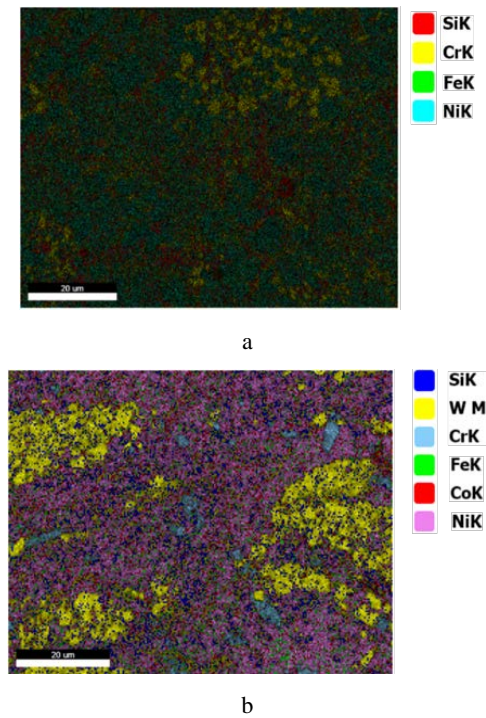
Fig. 7. SEM/Element overlay cartography of remelted coatings. Left: NiCrBSiFeC; Right: NiCrBSiFeC-WC(Co)

The elemental distribution in the composite NiCrBSiFeC-WC(Co) coating displayed in Fig. 7 b clearly shows that the cobalt attached to its original WC(Co) particle in the as-sprayed coating is uniformly redistributed throughout the microstructure after remelting. It is thought that the cobalt was dissolved in the Ni-based liquid alloy during the melting process because of its low melting temperature that can be reached during the melting process unlike the WC tungsten carbides. Accordingly, the resulting composite coating can be identified as WC carbide in a matrix of Ni-based alloy and Co. In addition, well-distinguished zones can be observed in both coatings. Based on elements' color distribution these obviously correspond to silicides, tungsten carbides and chromium compounds.

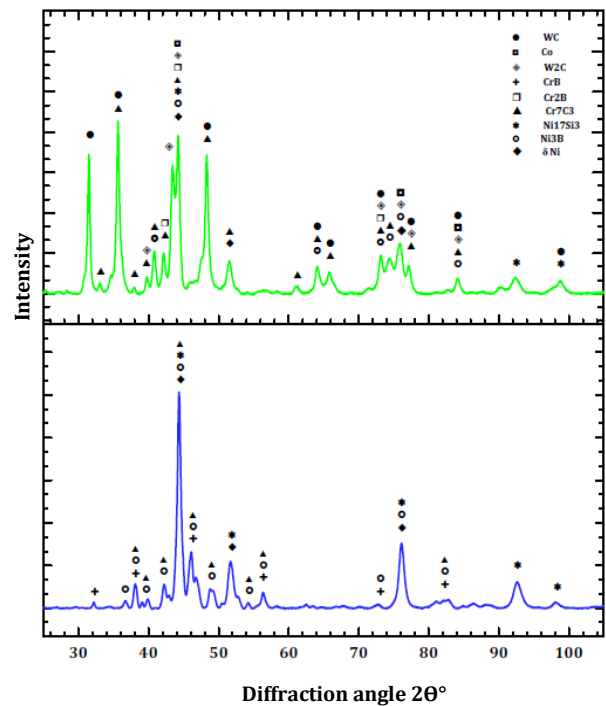
Fig. 8. XRD spectra of remelted coatings. Top: M30C; Below: NiCrBSiFeC

As portrayed in XRD pattern (Fig. 8), it can be noticed that the coatings clearly exhibit broad peaks with humps, which are more expanded in the composite. This is more likely associated with nanocrystalline matrix phases resulting from the high cooling rates related to thermal spray coating process [2, 13, 15].

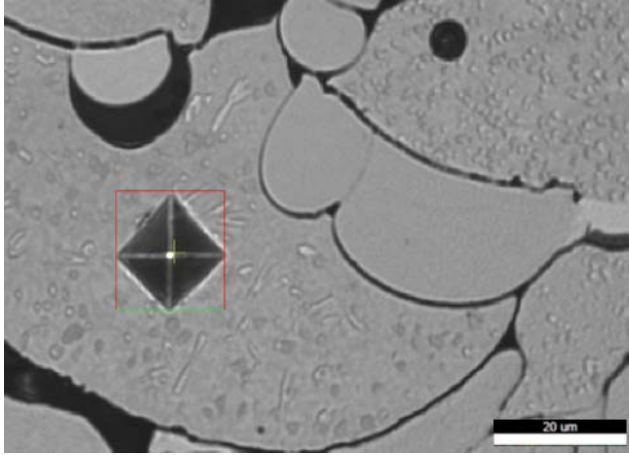
Fig. 9. Optical micrograph of an indent impression of as-sprayed NiCrBSiFeC coating under a load of 100 g

as-sprayed coatings while surface hardness is higher in remelted coatings, which is in agreement with reported results [5, 9, 23]. The high surface hardness of the remelted coatings could be mainly due to their high density owing to the reduction in porosity and enhancement of the coating cohesion as a result of the high temperature (1200–1500 °C) reached during the melting process [3, 9, 16]. The greater microhardness of the as-sprayed coatings may be due to their finer microstructure [5, 12, 15] (Fig. 9).

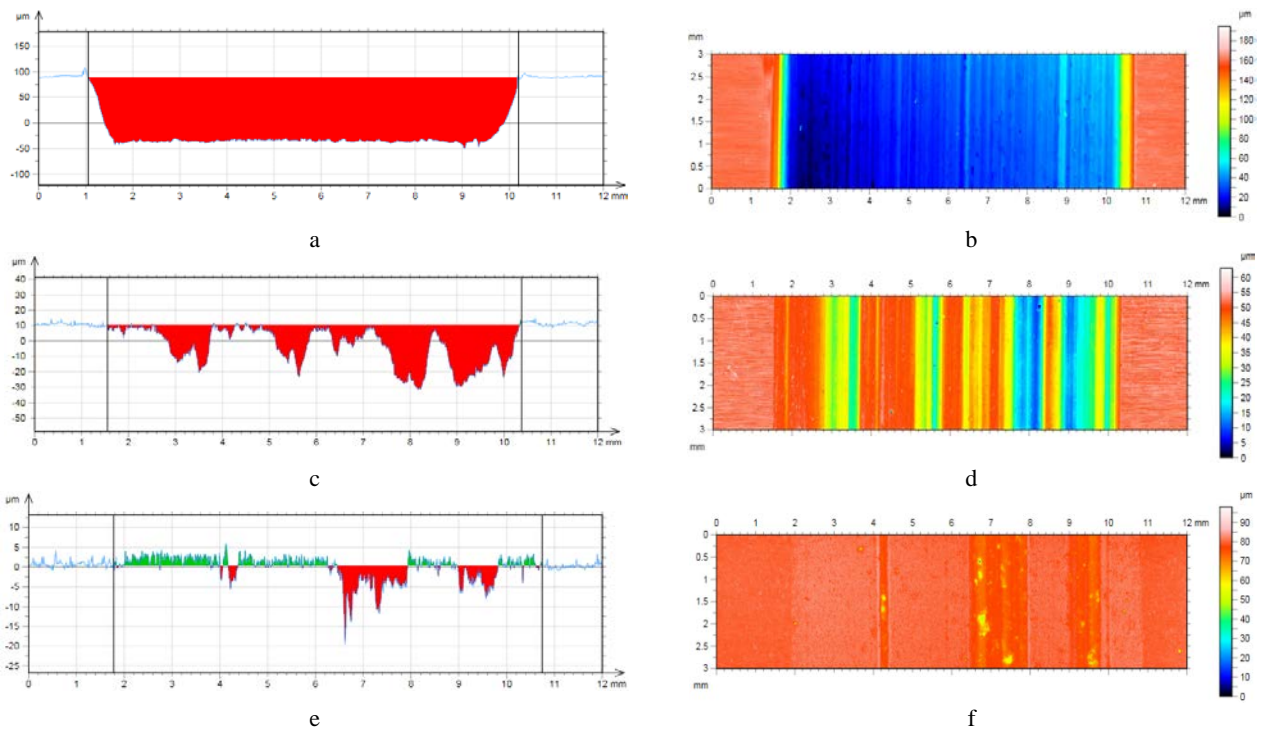
Fig. 10. 3 D non-contact surface mapping with cross section of the wear scars (Right) and wear track profiles of remelted coatings (Left). a, b – substrate; c, d – NiCrBSiFeC; e, f – NiCrBSiFeC-WC(Co)

3D profilometry and SEM investigations of the wear tracks on the substrate and the coatings suggest that several wear mechanisms, promoted by the reciprocating dry sliding had occurred simultaneously. As shown in Fig. 10 b, two-body abrasive wear occurred in the substrate, characterized by deep grooves parallel to the direction of sliding resulting from the relative motion between a soft surface (substrate) against a counterpart with harder asperities (pin). Consequently, a large fluctuation in COF (0.7–0.95) was induced (Fig. 12 a). The small black spots that can be seen in the figure are thought to be due to low oxidation. For the NiCrBSiFeC coating (Fig. 10 d and Fig. 11 a and b), several macro and microgrooves parallel to the sliding direction related to the abrasion mechanism can be observed. In addition, a significant adhesion layer is obviously visible, which may have accumulated on both sliding surfaces by plastic deformation and flattening of the debris under continuous sliding [3,14,23]. The high mutual solubility of the Ni (coating) and the Fe (pin) contribute considerably to the development of this phenomena. Thereby, the adhesion layer is a result of material transfer from the counter-body which is mixed to coating debris and oxidized during the wear process to form a thin tribolayer [3, 23, 25]. This latter smoothed the worn surface and exerted a protective function to the coating, inducing a significant reduction in friction and wear (Table 4). As a result, a short running-in stage and a very stable COF were recorded for the NiCrBSiFeC coating (Fig. 12 b). Fig. 11 .b also shows some voids related to micro-porosities probably revealed by the wear process. Some of these contain indeed piled up debris inside. For the composite coating, wear particles agglomeration phenomenon is well observed. The smaller wear particles have linked together and formed a larger single pile. Particle agglomeration had occurred simultaneously in confined locations at the top and bottom edges of the wear area. Since the sliding is performed in the vertical direction, some fragments of debris piles were subsequently detached by gravity, trapped in the contact surface, and then partially embedded in the pin surface, thus acting as fixed indenters. As a result, large and shallow wear marks are clearly visible on the surface of the coatings (Fig. 10 f and Fig. 11 c and d) which is a sign of two-body abrasive wear mechanism [27]. The width of the mentioned wear marks are in the range of 258 μm to 1.58 mm, which may give an indication of the size of the debris piles. Some craters can be observed on the worn surface, mostly on the matrix and apparently bigger within the wear marks, which suggests that a part of debris (or agglomerated debris) remain free to roll between the two mating surfaces and may be the basis of a three-body abrasion wear mechanism [12, 27].

(Fig. 12 c). The formation of a microfilm within the big marks and covering a large area of the wear track was also displayed (Fig. 10 f and Fig. 11 c). It is clearly indicated by the green area above the surface of the wear track (Fig. 10 e). This is a sign of tribo-oxidation mechanism, as reported in several previous research works [4, 10, 22, 28].

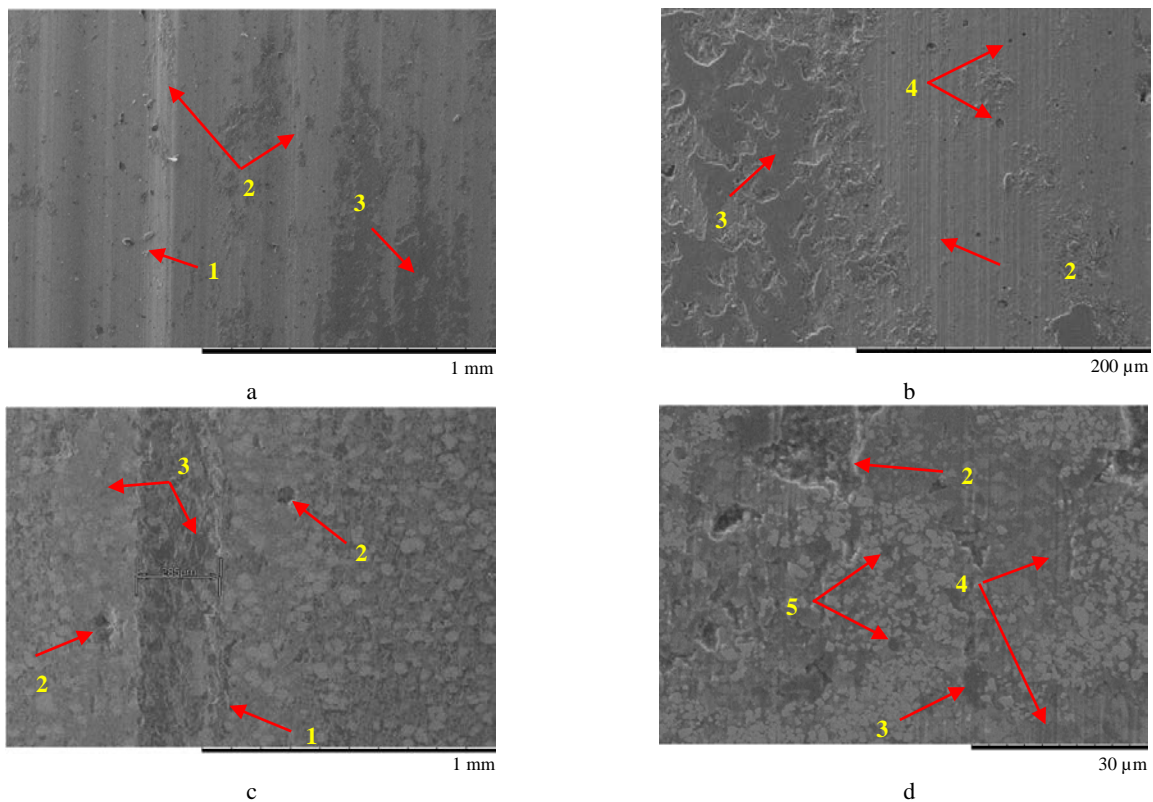
Fig. 11. SEM images of the worn surface of the remelted coatings: a, b – NiCrBSiFeC (1 debris; 2 grooves; 3 transferred layer; 4 micro-positivities); c, d – NiCrBSiFeC-WC(Co) (1 wear mark; 2 craters; 3 microfilm; 4 microgrooves; 5 micro-pits)

Some of these debris may be the results of the pulling out of the reinforcement phase. The craters are also visible in the counterpart supporting the idea of three-body wear mechanism. Due to this combined abrasive wear, the running-in stage was more extended and a large fluctuation in the COF is evident for the composite coatings (0.5 – 0.7)

In contrast to the NiCrBSiFeC coating, no material transfer to the counter-body was detected. At high magnification (Fig. 11 d), it can be clearly seen that microgrooves are well noticeable on the matrix but interrupted in the WC carbides zone.
