Shaft Surface Roughness and its Influence on the Wear of the Lip Sealing Edge

M. Gawliński*, Z. Kasprzyk

Wrocław University of Technology, ul. Wybrzeże Wyspiańskiego 27, PL-50 370 Wrocław, Poland

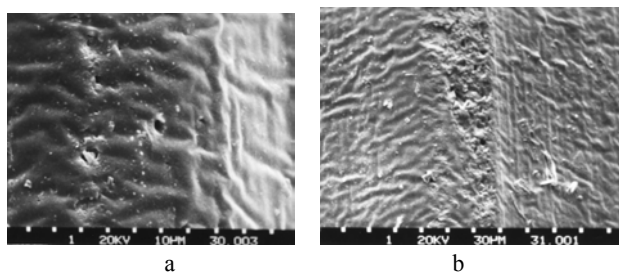
Fig. 1. An outlook of the sealing edge sectors under ESM in the oil lip seal operating on the plunge ground shaft through 200 hours, a – unworn surface, b – worn surface

Qu [2] investigated the influence of the shaft surface roughness on the leakage; he found that the oil lip seals were tight then, when the chosen surface roughness parameters had the following values: skewness $R_{sk} > 0.4$; kurtosis $R_{ku} < 4.0$; reduced depth of the valleys $R_v < 3.8 \mu\text{m}$ and the roughness average $0.25 \leq R_a \leq 0.5 \mu\text{m}$. However, Horve reported [3] that the oil lip seals with the smooth surface of the sealing edge were more often leaking than those with rough surface. It follows, that the shaft surface irregularities should not only create but also maintain the proper texture of the sealing edge surface during oil lip seal operation. Following this thesis Gawliński found [4] that in the one and the same oil lip seal operating on the plunge ground shaft, one can meet the lip sectors with and without the traces of the wear (Fig. 1).

The measurements have revealed that the relative position (expressed in terms of the contact width of the lip

and the shaft) of the contact region along the sealing edge can vary over the lip perimeter within two or three contact widths.

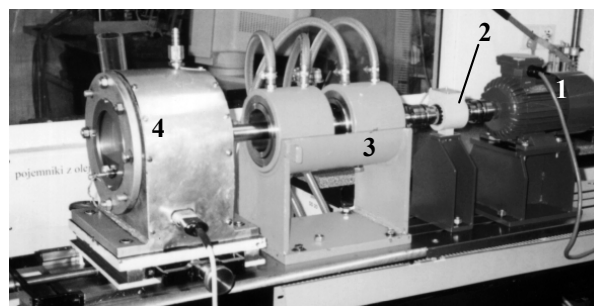
Fig. 2. Test rig for power consumption evaluation, 1 – electric motor, 2 – torquemeter, 3 – areostatic bearings 4 – test chamber

The oil lip seals were run on the test rig presented in Fig. 2. The shaft of the test rig is supported in two aerostatic bearings; it is driven by an electric motor with the angular speed up to 1000 rad/s. The torque was measured with aid of the inductive torquemeter with the measuring range (0 – 2) Nm. Time of the oil lip seal operation was 20 hours; the fluid to be sealed was mineral oil SAE 30 at temperature of 60 °C.

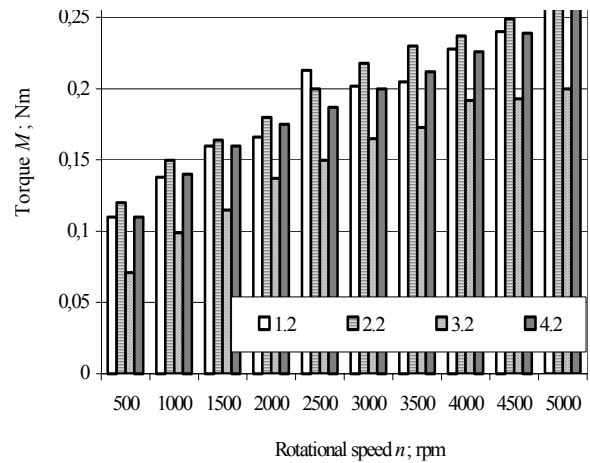
Fig. 3. Torque dependence on the shaft speed after 20 hours of continuous operation

Time of twenty hours of the continuous operation was sufficient to change the surface texture of the lip as well as the lip profile due to the wear process. It resulted in the change of the contact pressure as well as of the lubrication conditions between the lip and the shaft. The shaft surface roughness, on the other hand, experienced only slight changes in that time interval. The torque values recorded after 20 hours of operation at constant speed of $n = 1000$ rpm are presented in Fig. 3 and Fig. 4; torque is determined here as a function of the shaft speed. Comparison of the torque values at the beginning and at the end of the tests shows that the frictional losses

decreased irrespective of the shafts surface roughness; torque decreased by factor of two at the speed of 1000 rpm.

It seems to be a bad surface feature when high ratio $\frac{R_t}{r}$ is combined with mean value of the critical approach ε_{crit} of the rubbing surfaces. Seals running on the shafts 1.2; 2.2 show the highest values of the torque with increase of the shaft speed. The same effect can be met when the seal operates on the shafts with very small skewness R_{sk} and high kurtosis (shaft No: 6.2). High value of the critical approach ε_{crit} when combined with the low value of R_t/r ratio seems to be advantageous with respect to the friction losses; seals operating on the shafts 3.2; 5.2 and 7.2 distinguished themselves with low power consumption. However, one should keep in mind that the torque is affected by the contact conditions between the lip and the shaft, too. Therefore, the final conclusions about the surface roughness influence on the torque should follow an analysis of the sealing edge wear over the lip perimeter.

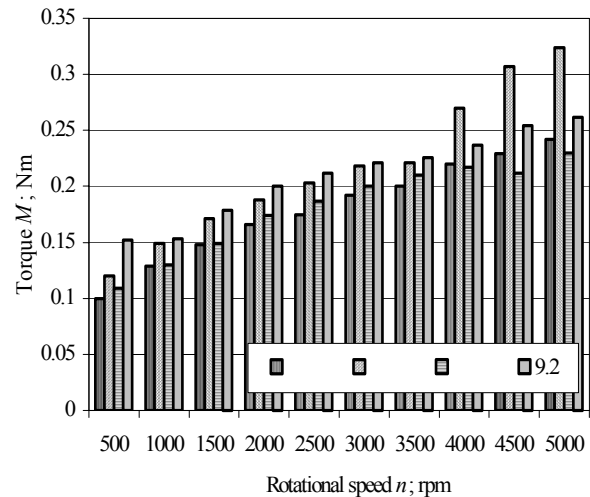
Fig. 4. Torque dependence on the shaft speed after 20 hours of continuous operation
